REVISED WEST CULBURRA BEACH CONCEPT PLAN

AQUATIC ECOLOGY ASSESSMENT REPORT

**Marine Pollution Research Pty Ltd
November 2020**

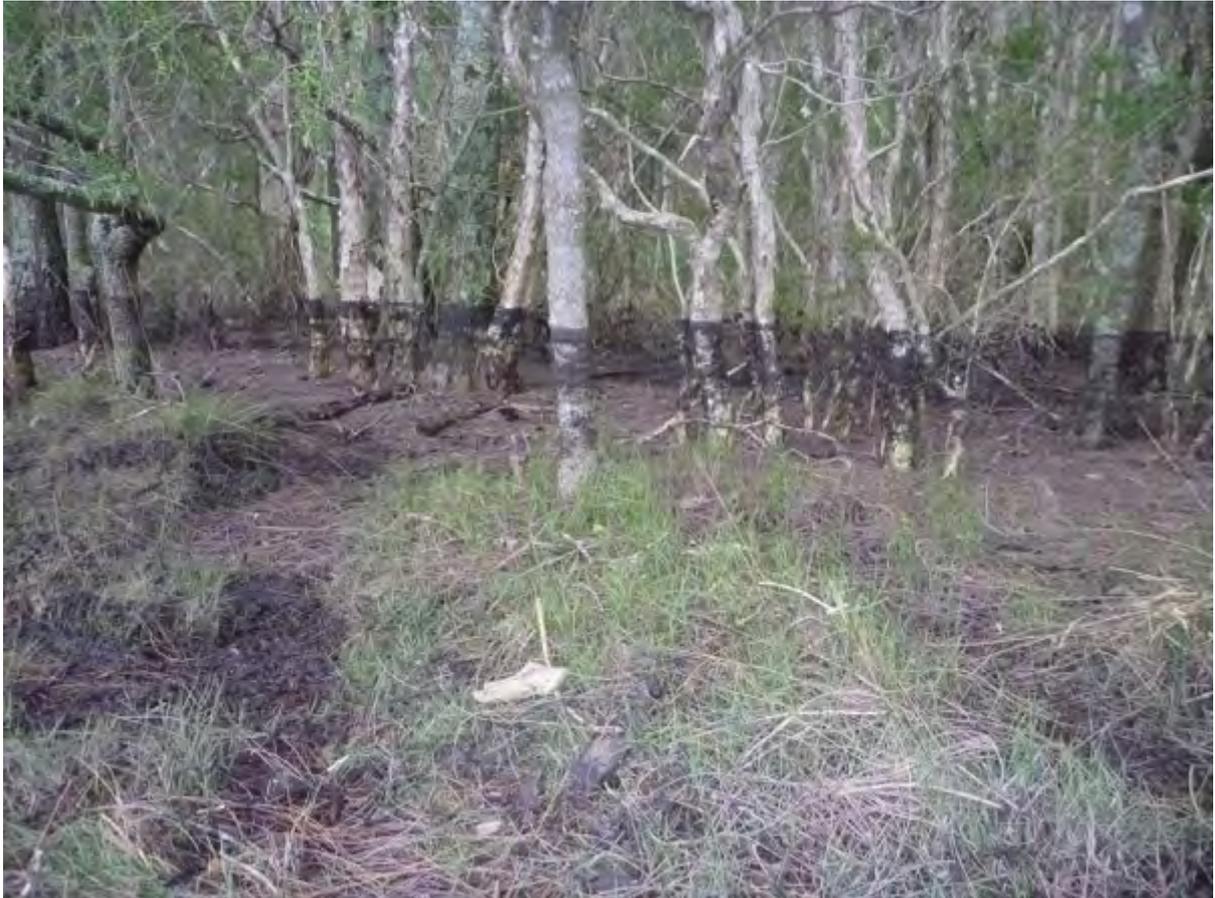
February 2020 Flood Peak Line delineated by floating bushfire debris - site along the Billys Bay foreshore approximately in line with the revised Concept Proposal western limit line.

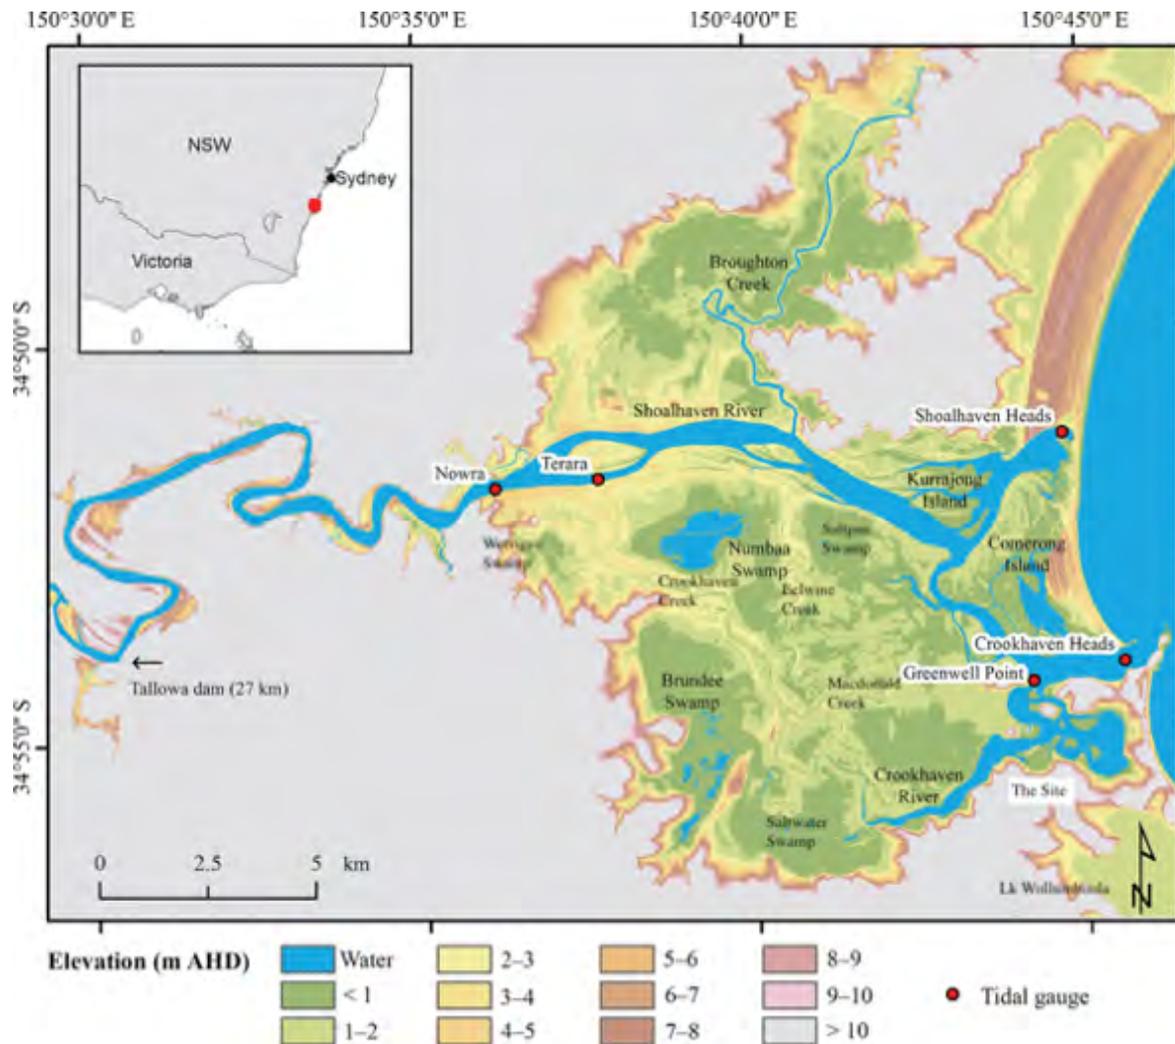
Figure 5 Shoalhaven/Crookhaven Estuarine Floodplain (after Kumbier et al (2108).

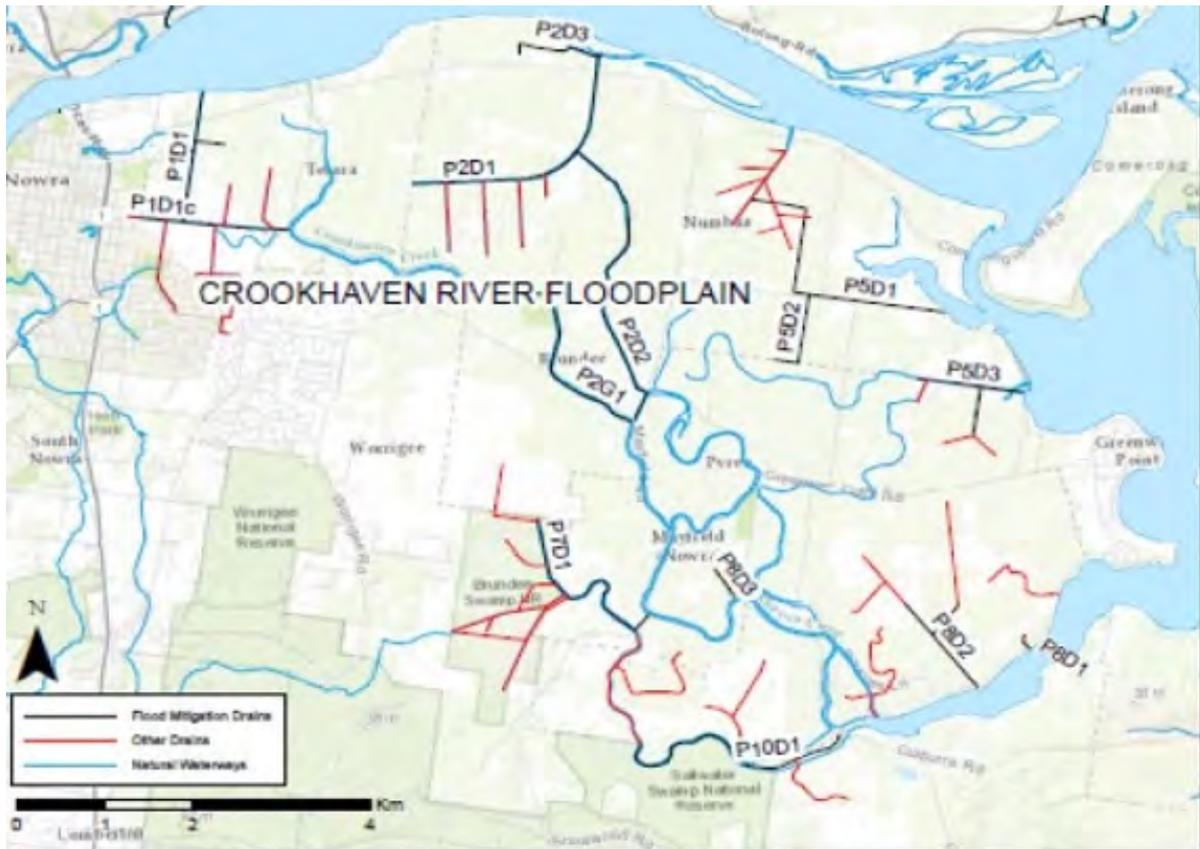
Figure 6 Flood Mitigation Drains and Structures in Crookhaven River floodplains (from Glamore et al 2016).

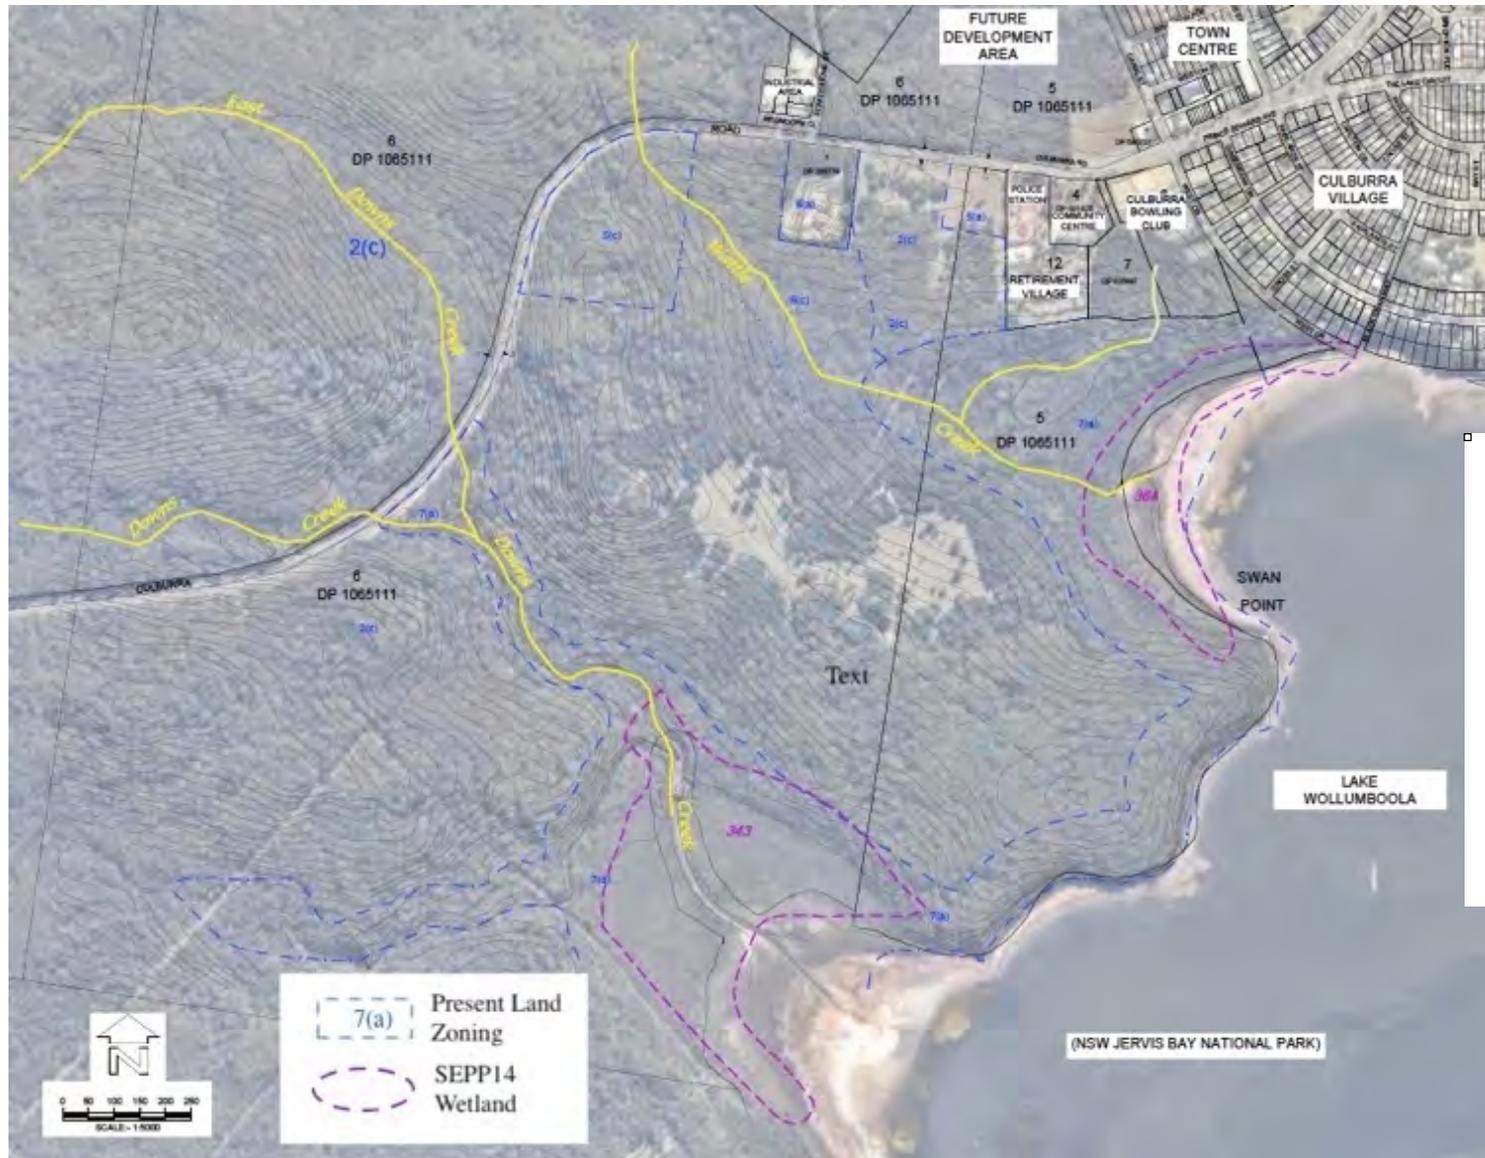
Figure 7 Location of East Downs and Wattle Creek Sub-catchment drainages to Lake Wollumboola (from AP&S Drawing 25405-227).

The original West Culburra Proposal included segments draining to Lake Wollumboola via two sub-catchments - an unnamed portion of Downs Creek (named East Downs Creek for this assessment) and Wattle Creek (see **Figure 3**). A more detailed topographic map of these sub-catchments was provided by Allen Price & Scarratts (AP&S), and **Figure 7** is a copy of this figure with the drainage lines indicated. The current proposal does not include any development in the Downs Creek sub-catchment and there is only a minor 0.5 Ha drainage associated with the roundabout and entrance road for the present proposal draining to Wattle Creek from Culburra Road.

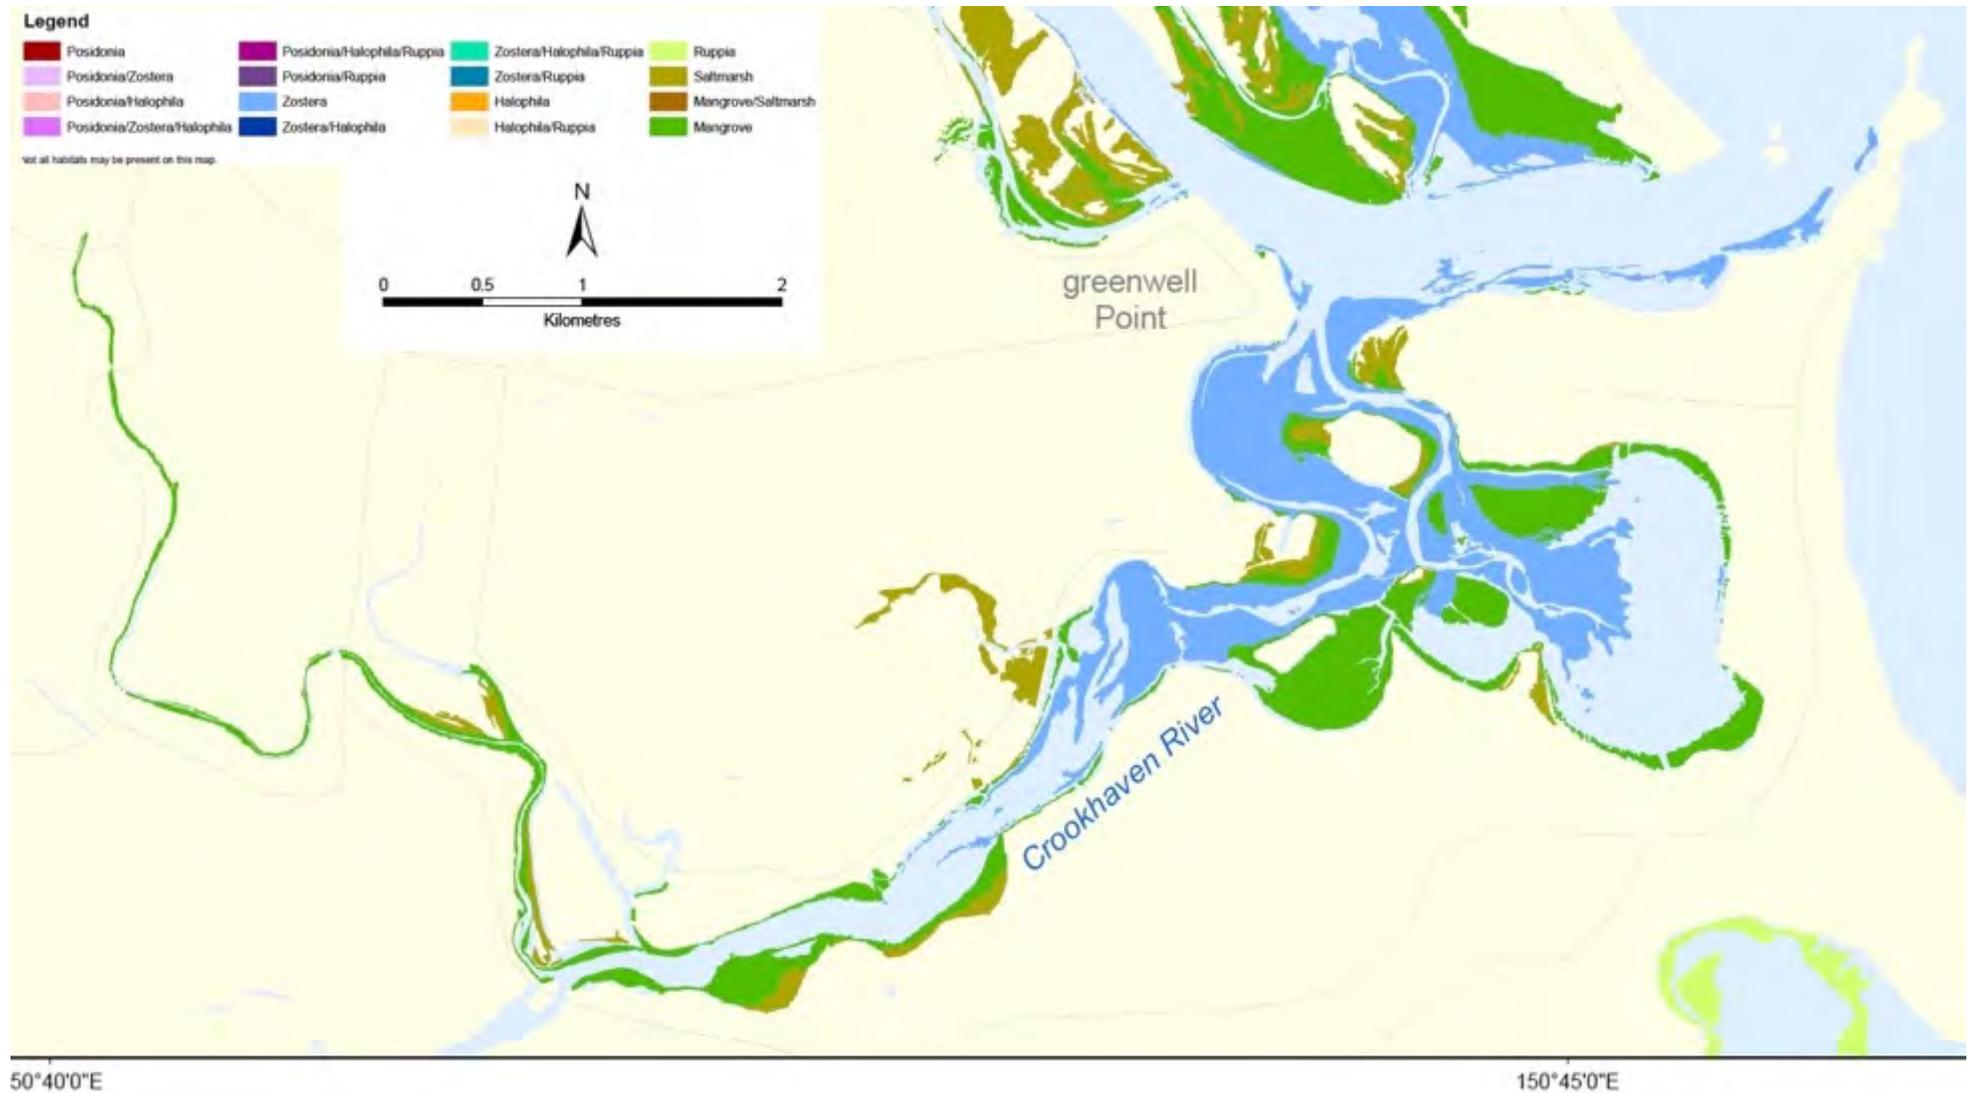
Figure 9 DPI Fisheries' Estuary Vegetation Mapping for Crookhaven River (part Map 47a). Aerial Photo 2000 and Field surveys 2003.

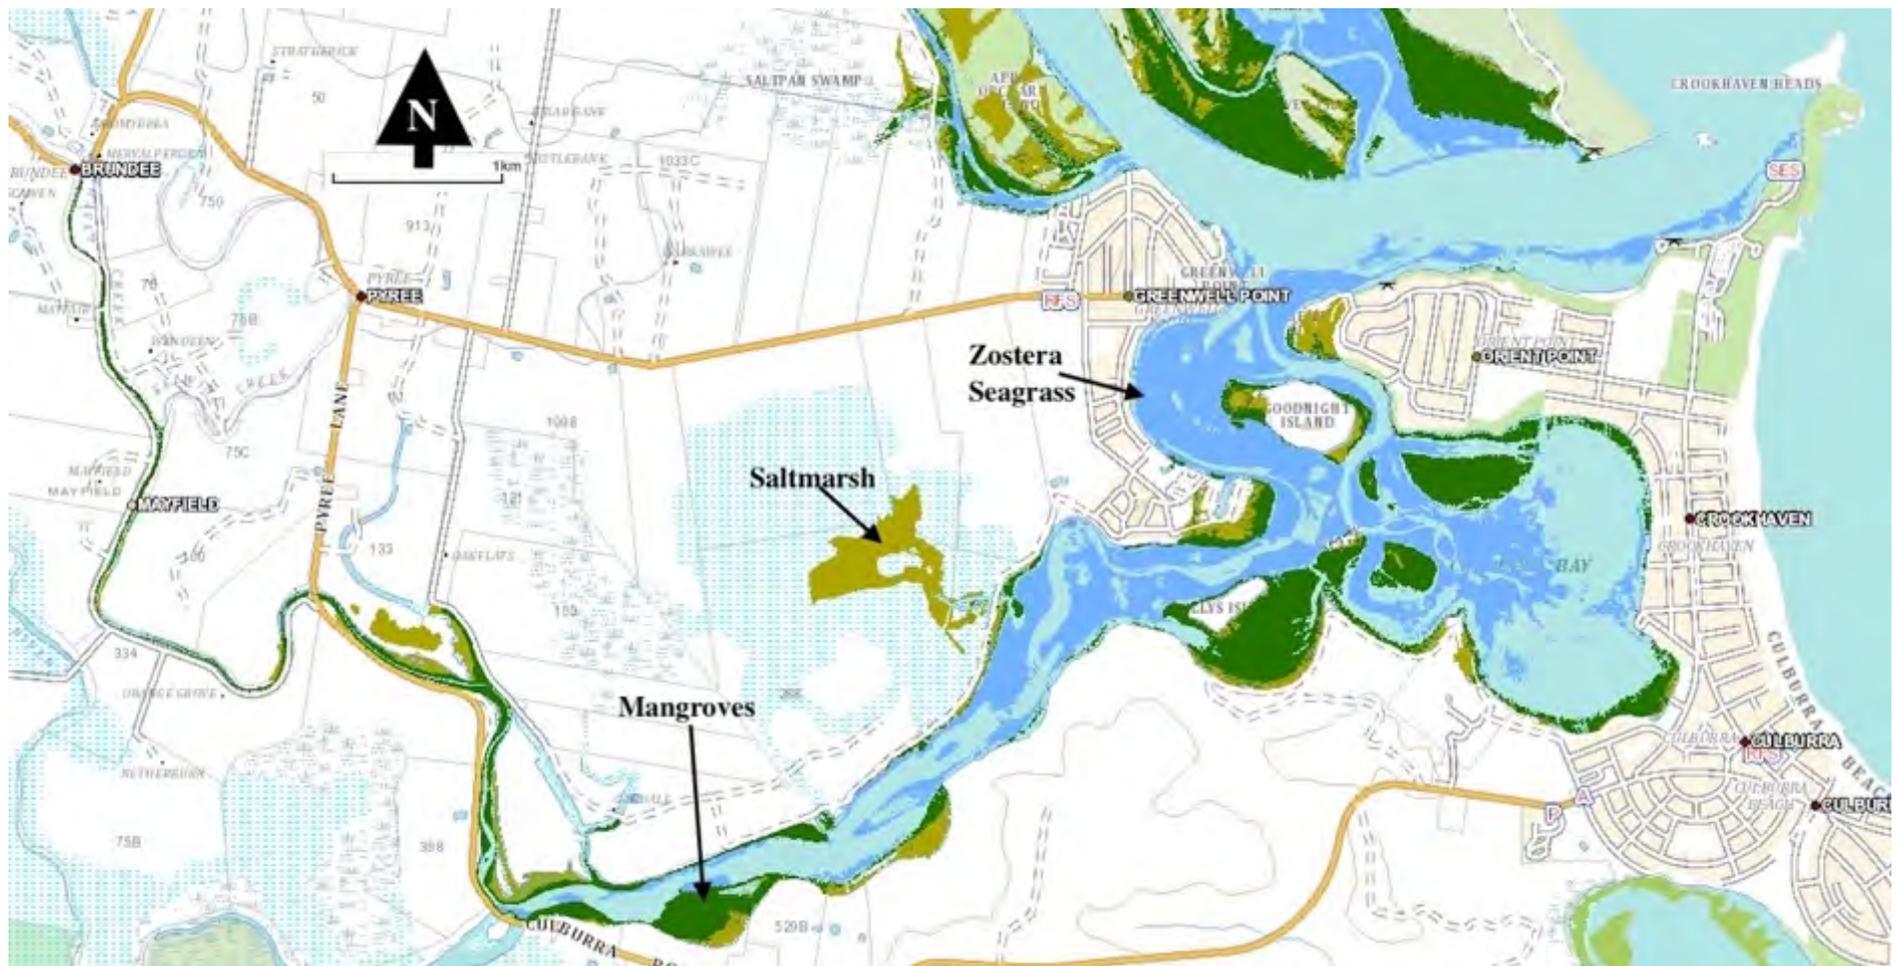
Figure 10 DPI Fisheries' Estuary Vegetation Mapping for Crookhaven River (part Shoalhaven Map). Aerial Photo 2009 and Field surveys 2010.

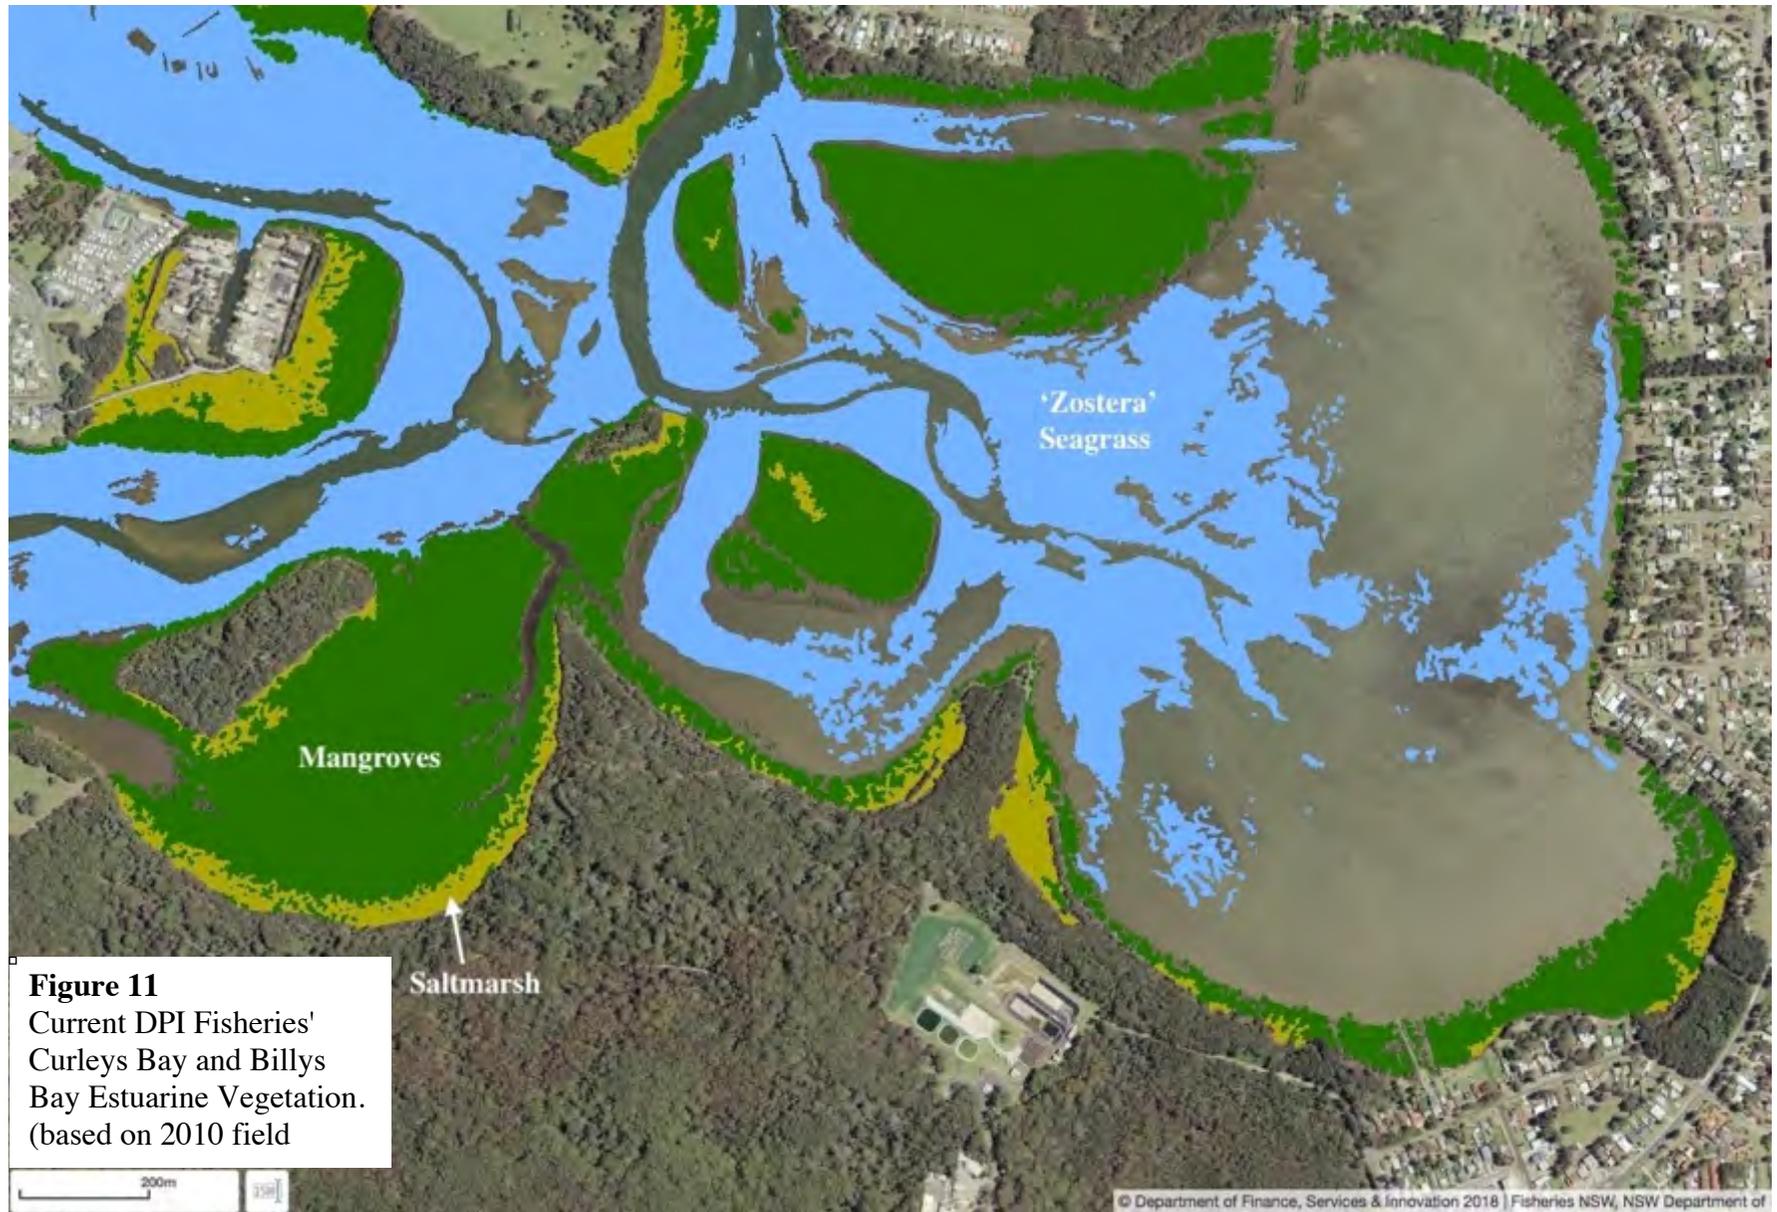
Figure 11
Current DPI Fisheries'
Curleys Bay and Billys
Bay Estuarine Vegetation.
(based on 2010 field

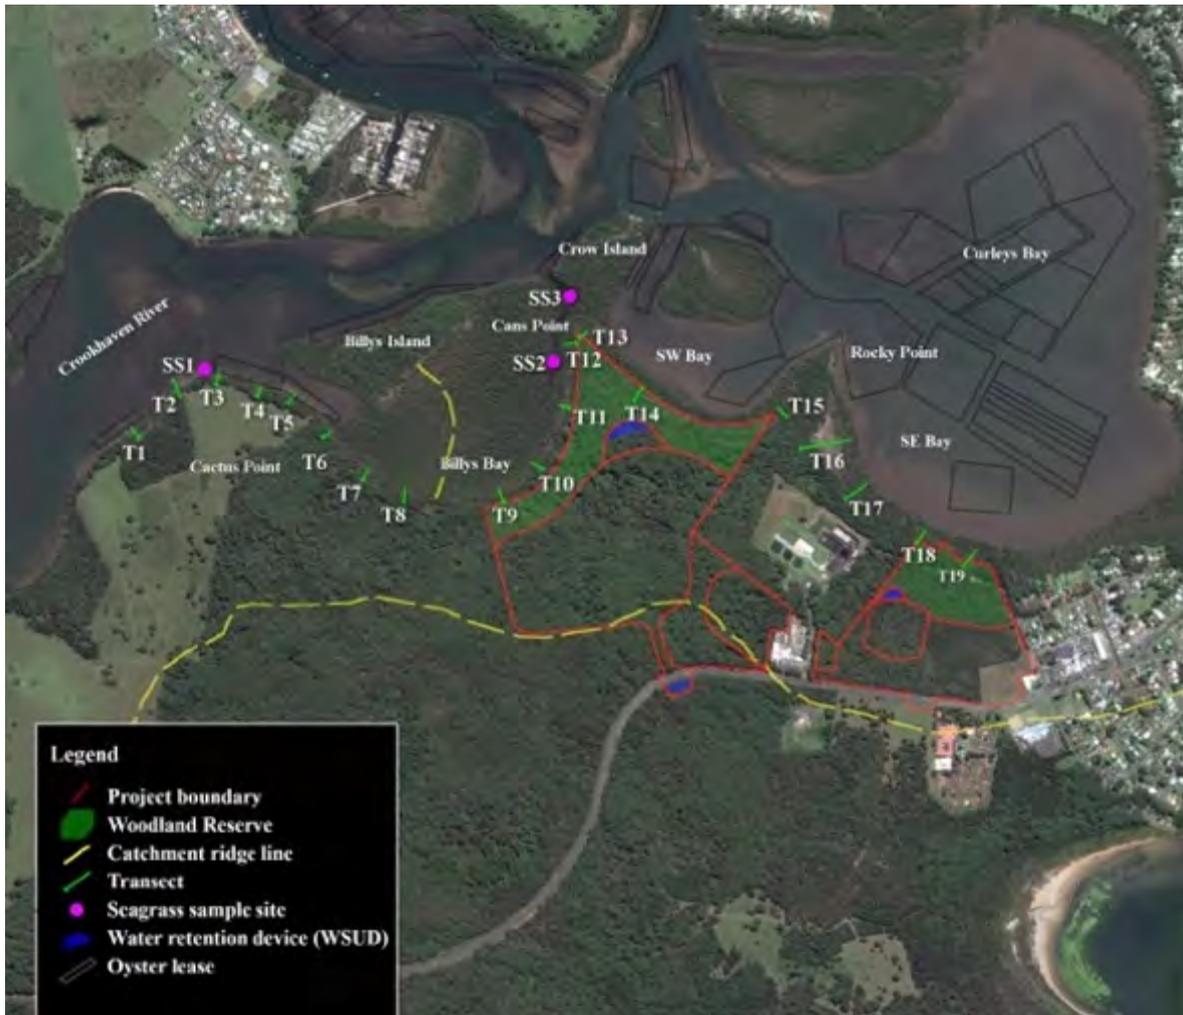
Figure 12 Estuarine aquatic ecology habitat assessment sites boarding the revised West Culburra Beach Concept Plan site. Note the delineation of mangrove drainage catchment areas inshore in Billys Bay (long dashed yellow line).

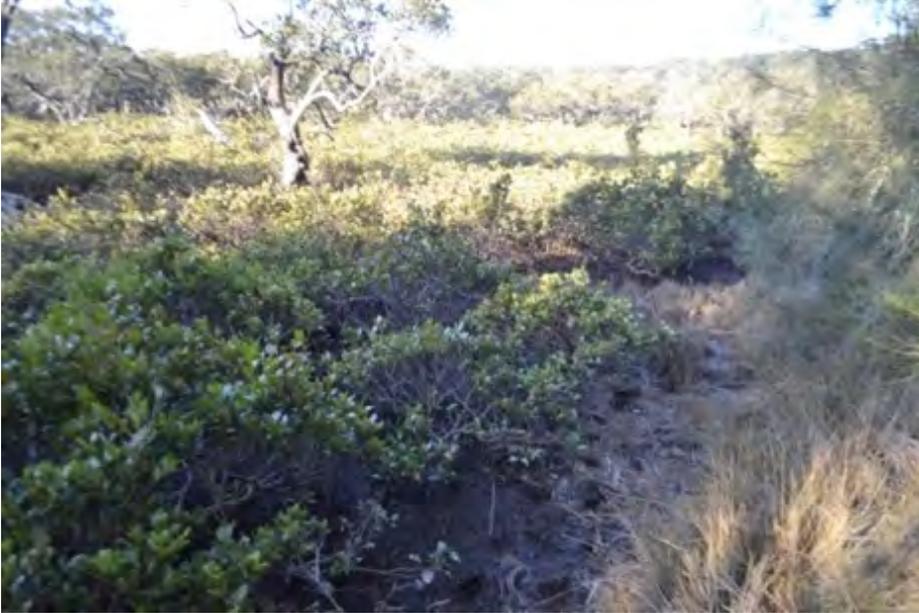
Figure 14 Close up view of Stunted or Dwarf Grey Mangroves between T7 and T8, (Photo 15 October 2019).

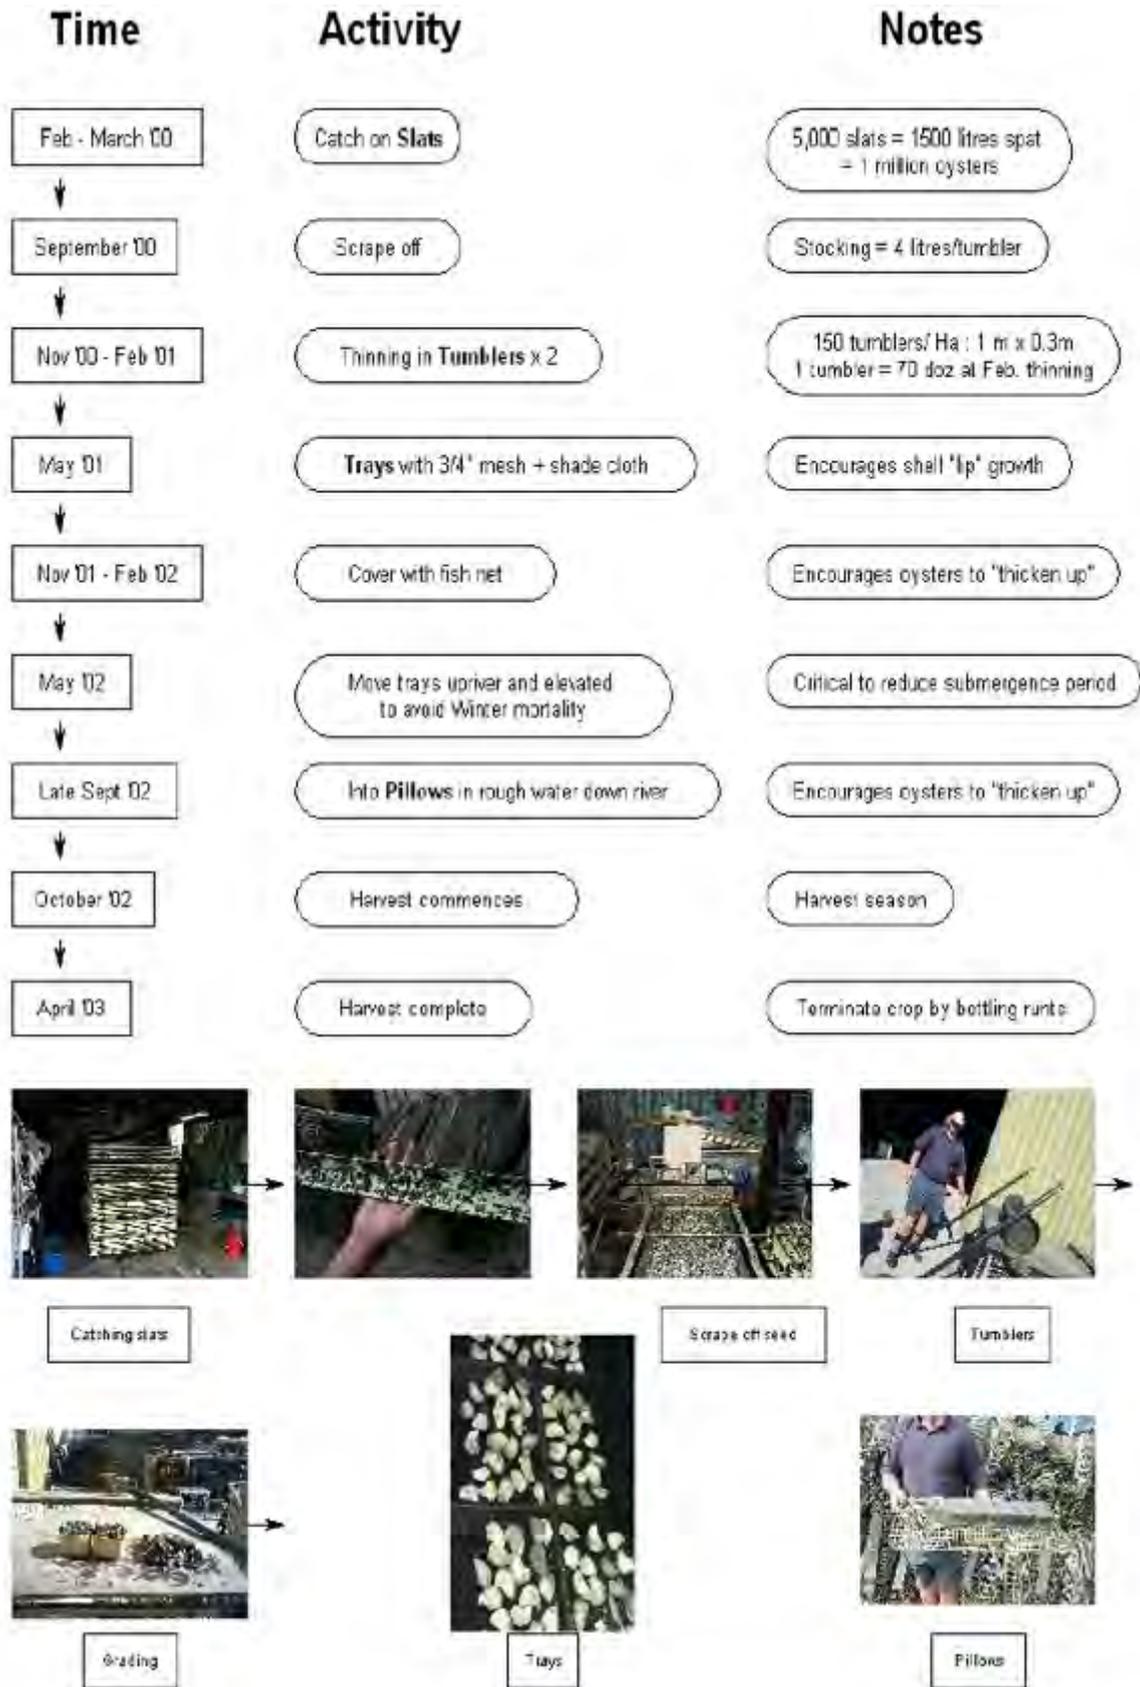
Figure 16 Oyster farming system used in the Crookhaven Estuary based on the year 2000 oyster spat collection - From Figure 26 in Ogburn (2011) and courtesy of Shoalhaven Oyster Services Pty Ltd.

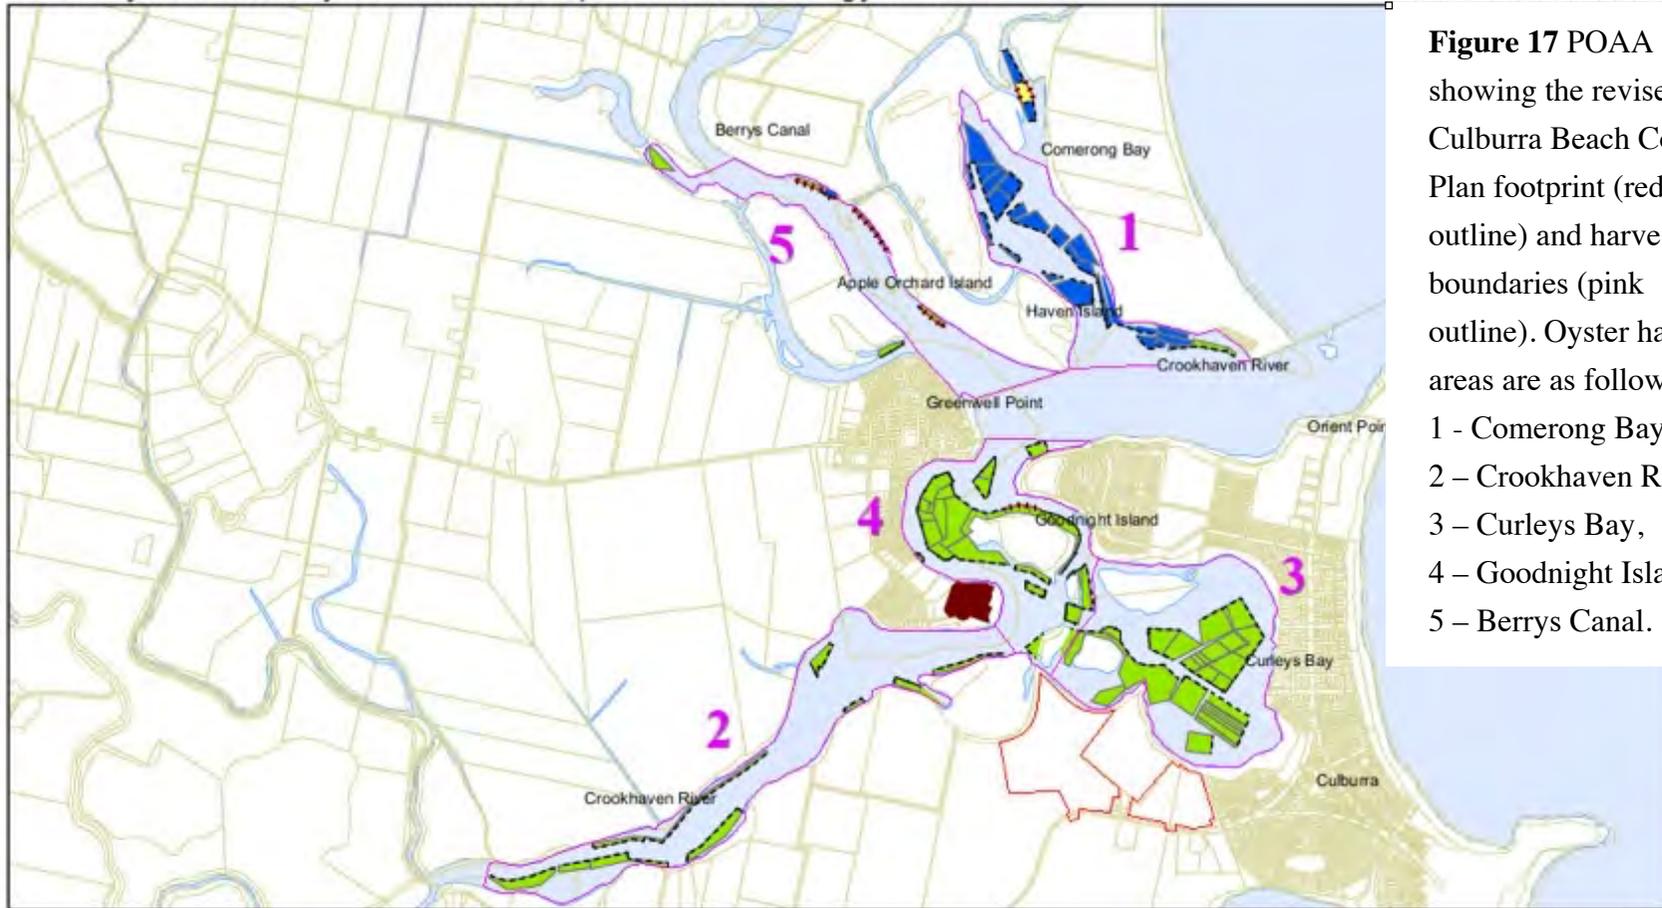
Figure 17 POAA Map showing the revised Culbura Beach Concept Plan footprint (red outline) and harvest area boundaries (pink outline). Oyster harvest areas are as follows;
 1 - Comerong Bay,
 2 – Crookhaven River,
 3 – Curleys Bay,
 4 – Goodnight Island,
 5 – Berrys Canal.

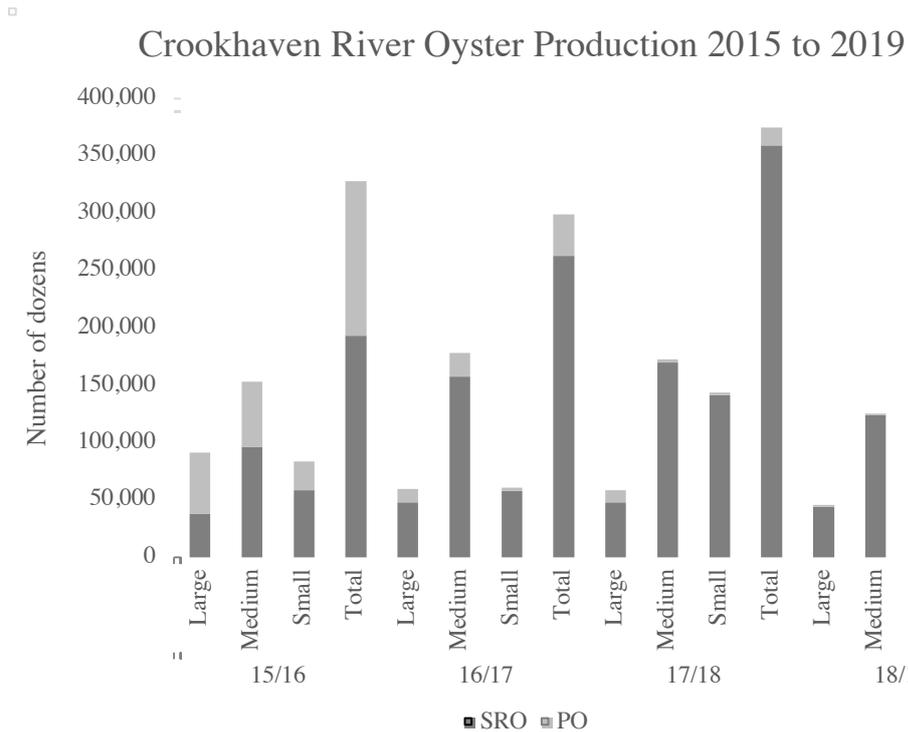
Figure 18 Crookhaven River oyster production figures over the last four years (data source: NSW DPI 2020)

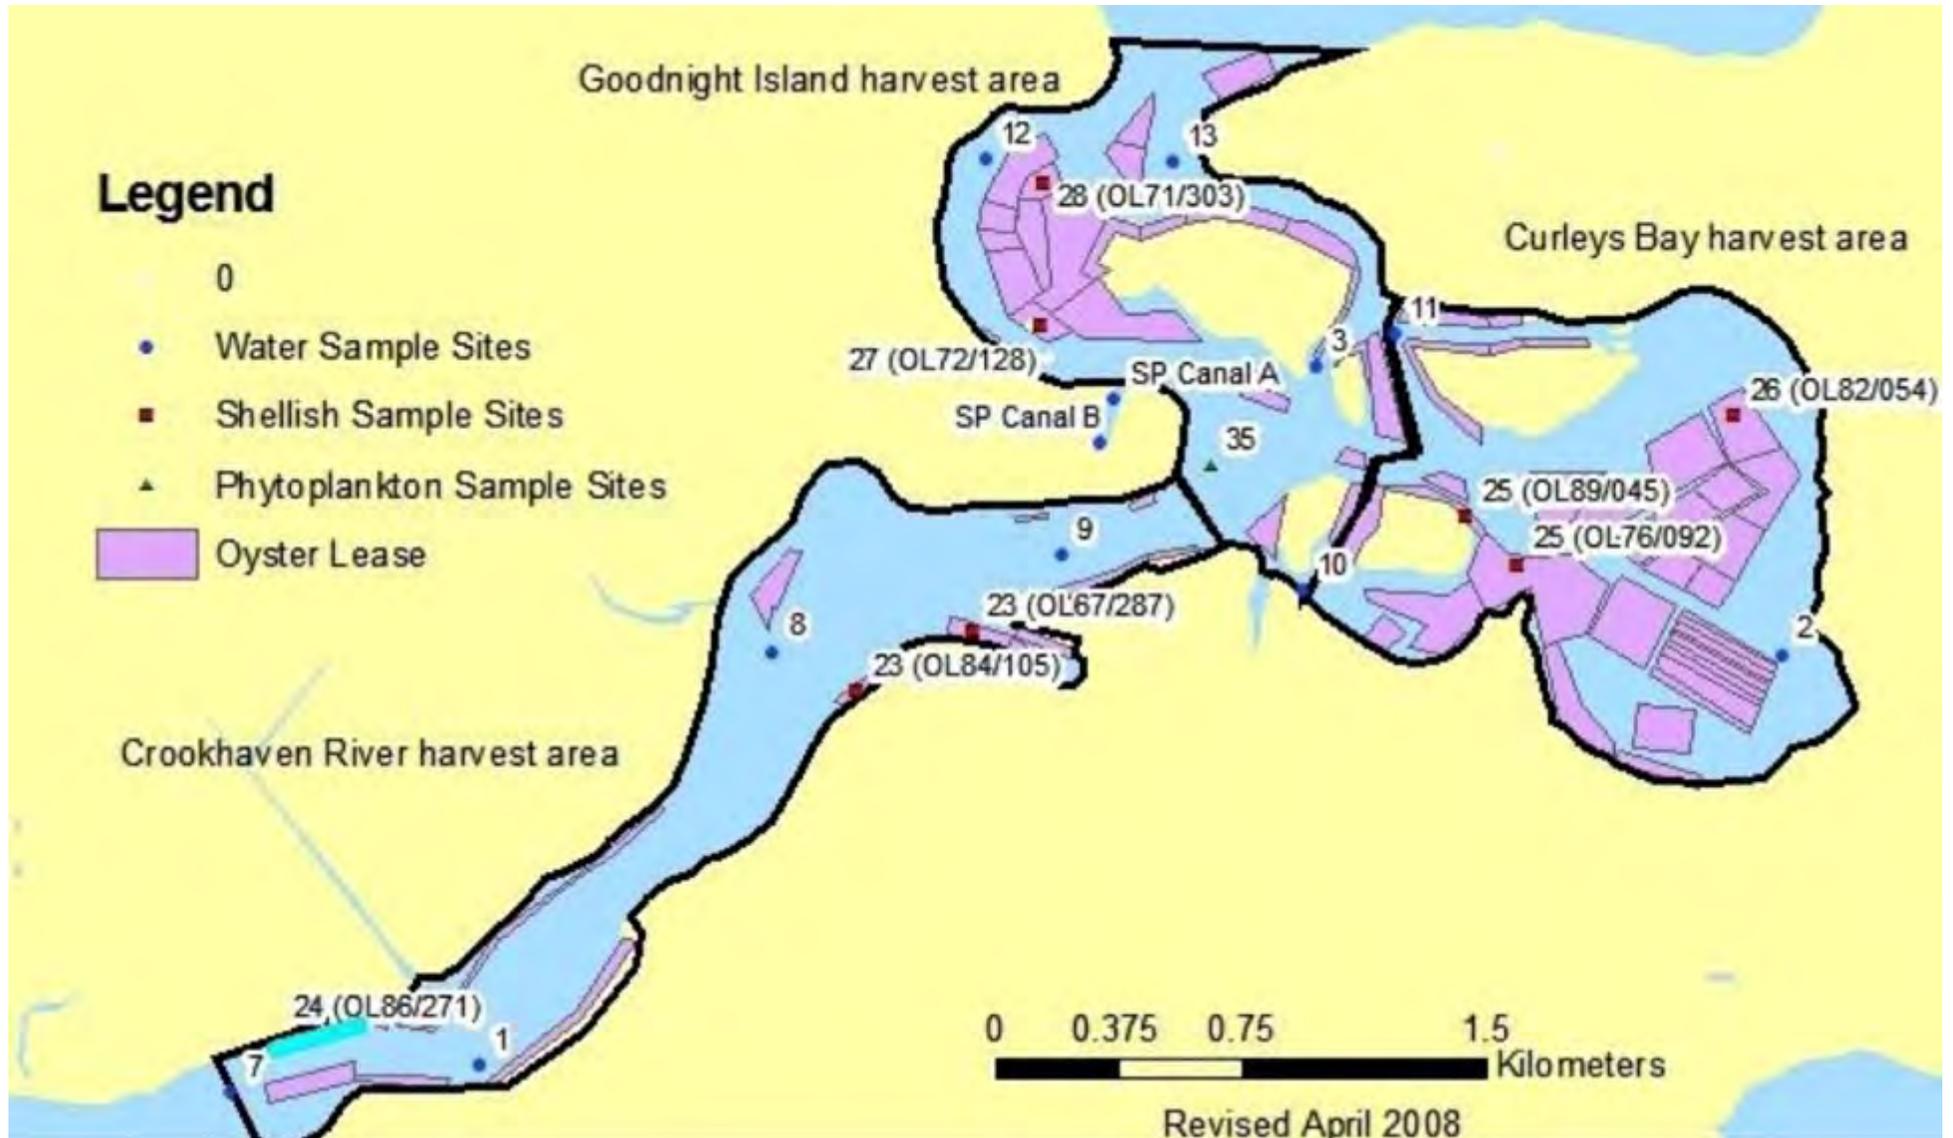
Figure 19 Shoalhaven River Shellfish Program Crookhaven River Sample Sites

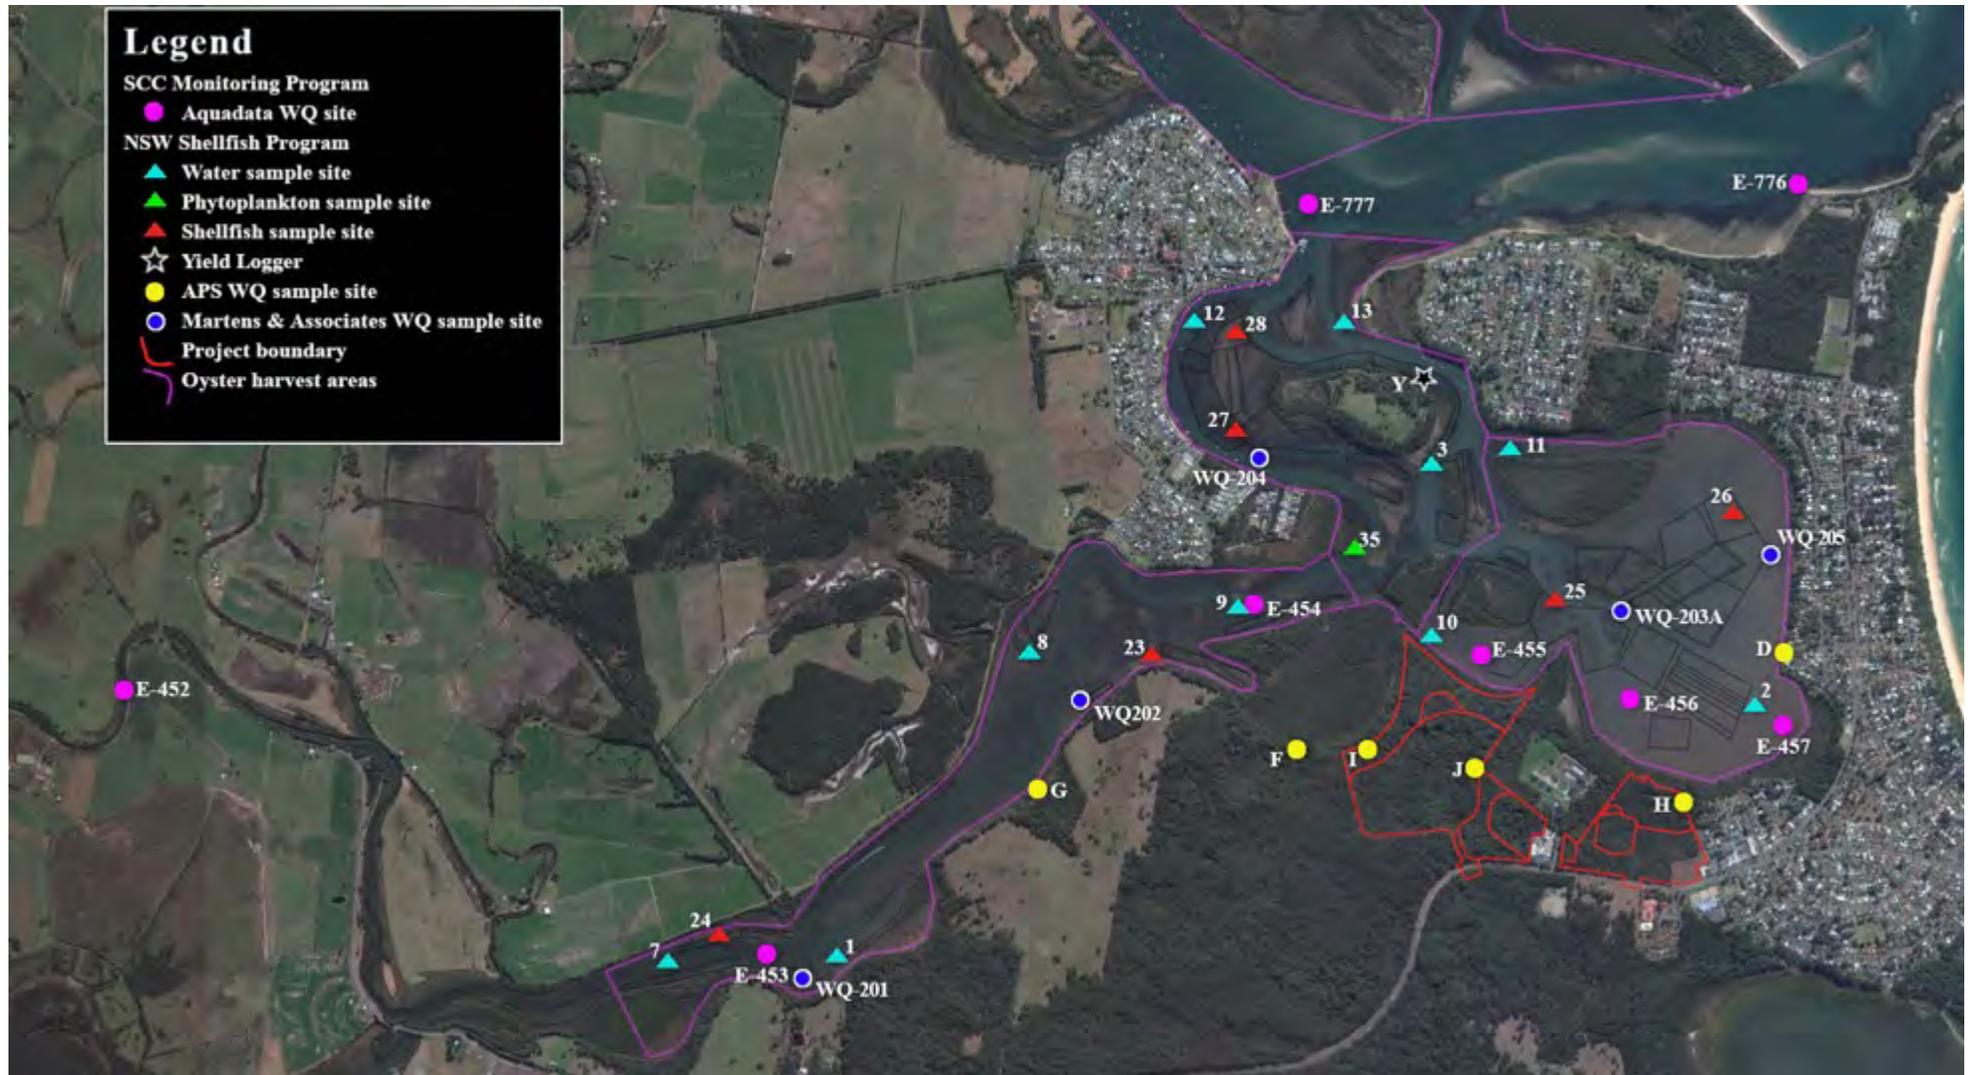
Figure 20 Combined Crookhaven River Water Quality Sampling Sites

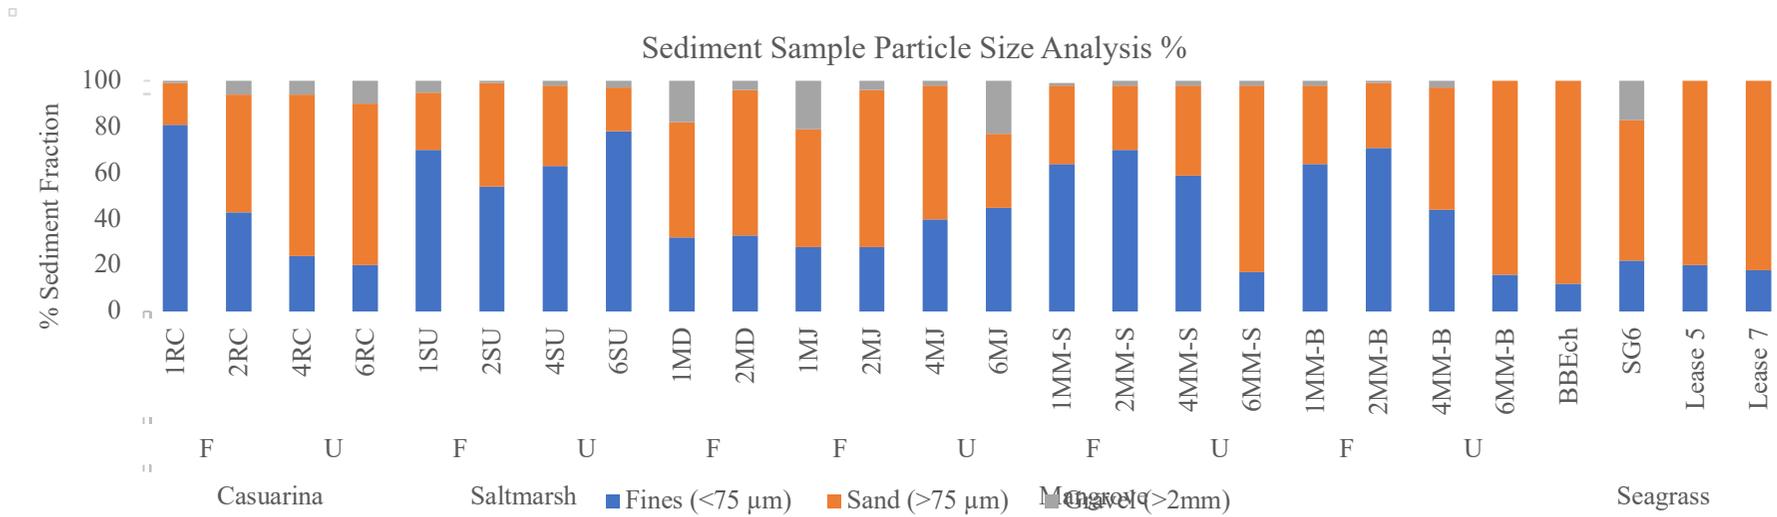
Figure 22 Sediment sample particle size distribution (% total)
