REVISED WEST CULBURRA BEACH CONCEPT PLAN

AQUATIC ECOLOGY ASSESSMENT REPORT

**Marine Pollution Research Pty Ltd
November 2020**

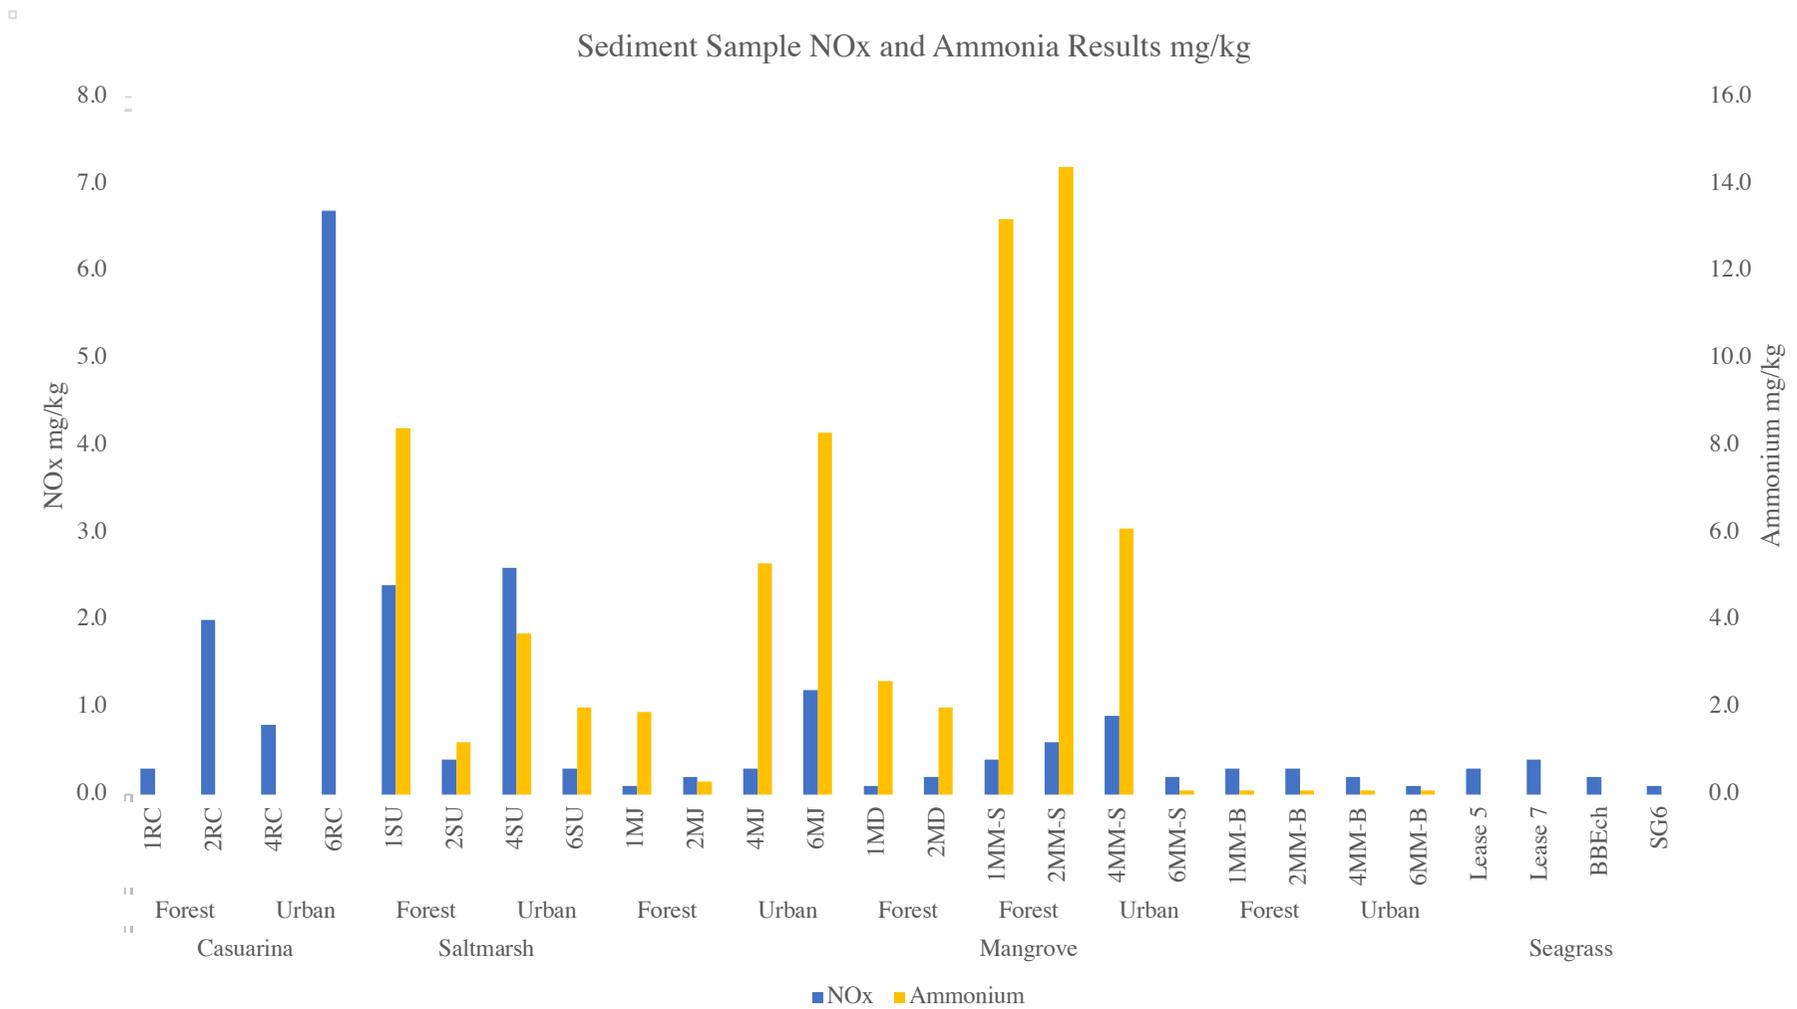
Figure 24 Sediment sample Nitrous Oxides (NOx) and Ammonia concentrations

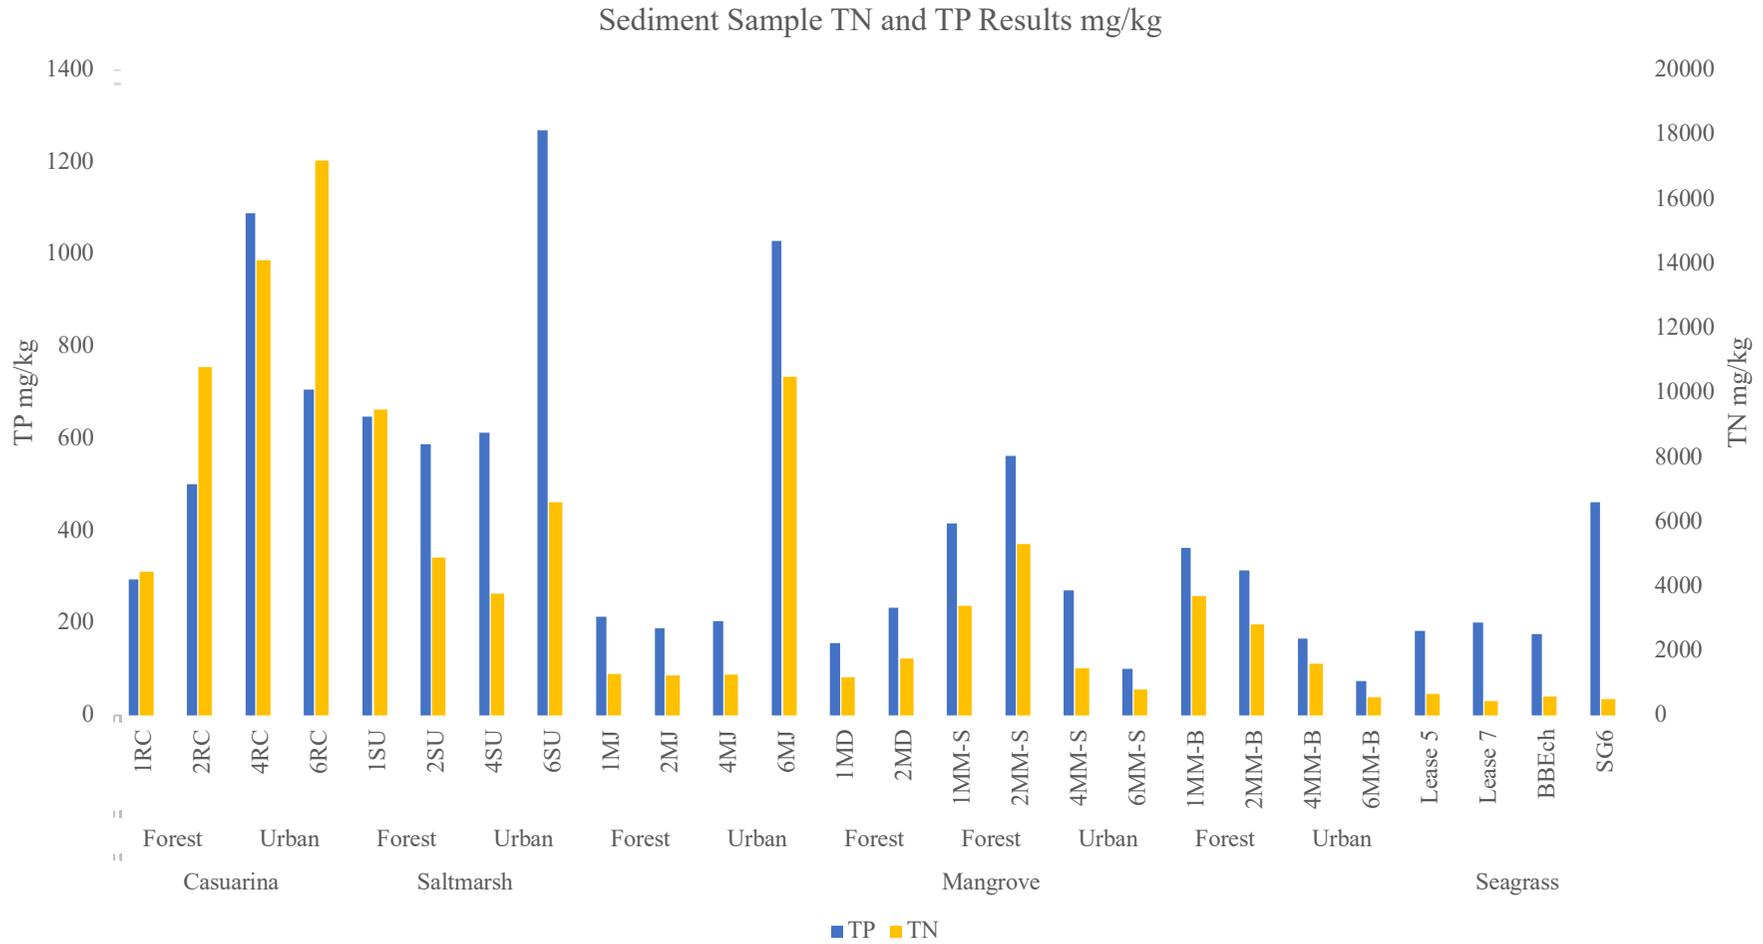
Figure 25 Sediment sample Total Nitrogen (TN) and Total Phosphorus (TP) Concentrations (log scale)

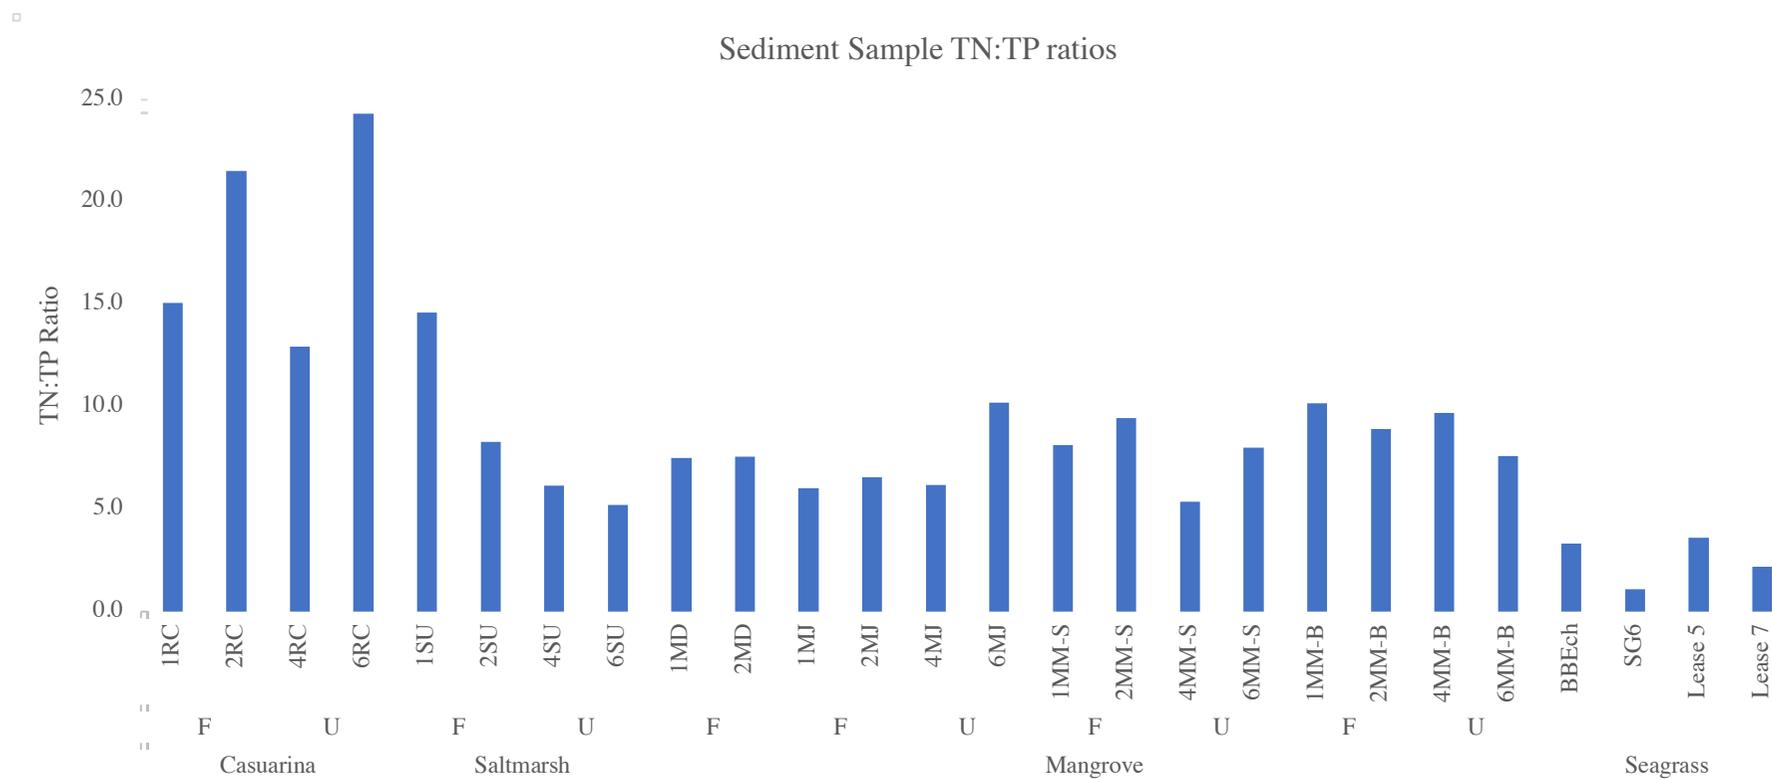
Figure 26 Sediment sample TN to TP ratios

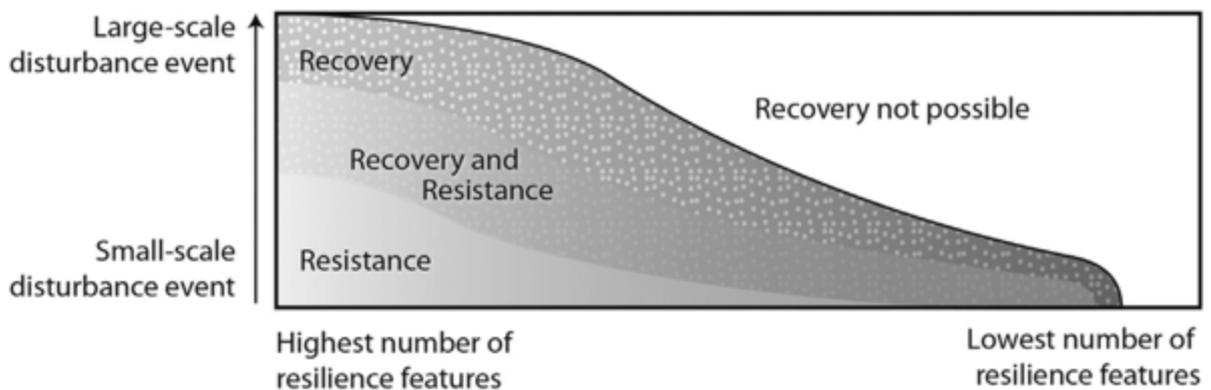
Figure 27 Conceptual Model of Ecosystem Resilience (from Unsworth et al 2015).

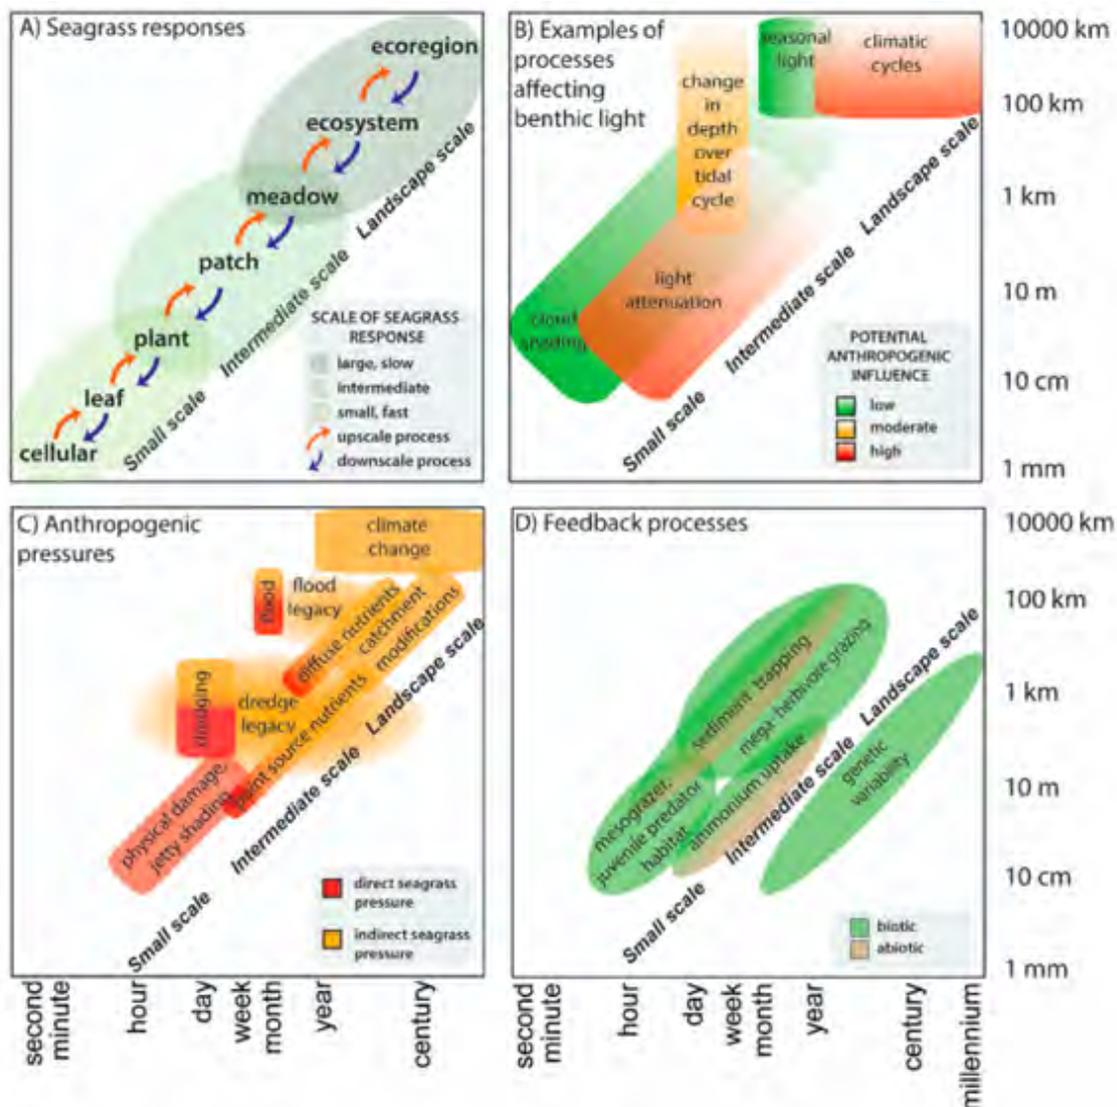
Figure 28 O'Brien et al (2018) The trajectories of degradation and recovery observed in seagrass ecosystems arise from cumulative responses to natural and anthropogenic processes, interacting across a range of temporal and spatial scales.

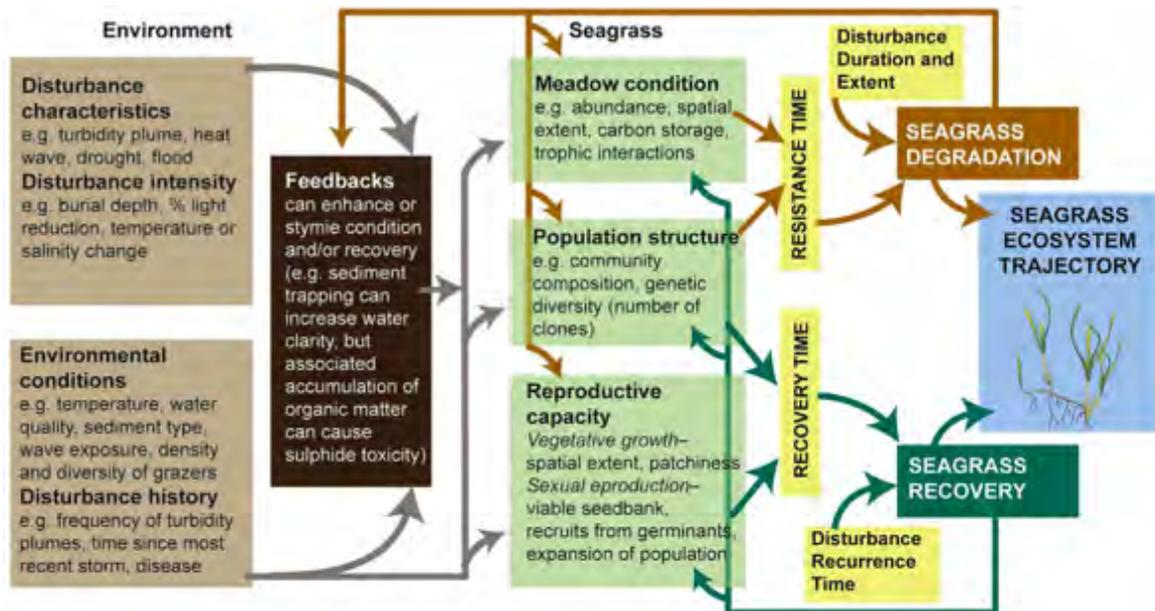
Figure 29 O'Brien et al (2018). The trajectory of a seagrass ecosystem in response to disturbance depends on the degree of degradation and recovery which in turn depend on the relative timescales of resistance, recovery and disturbance.

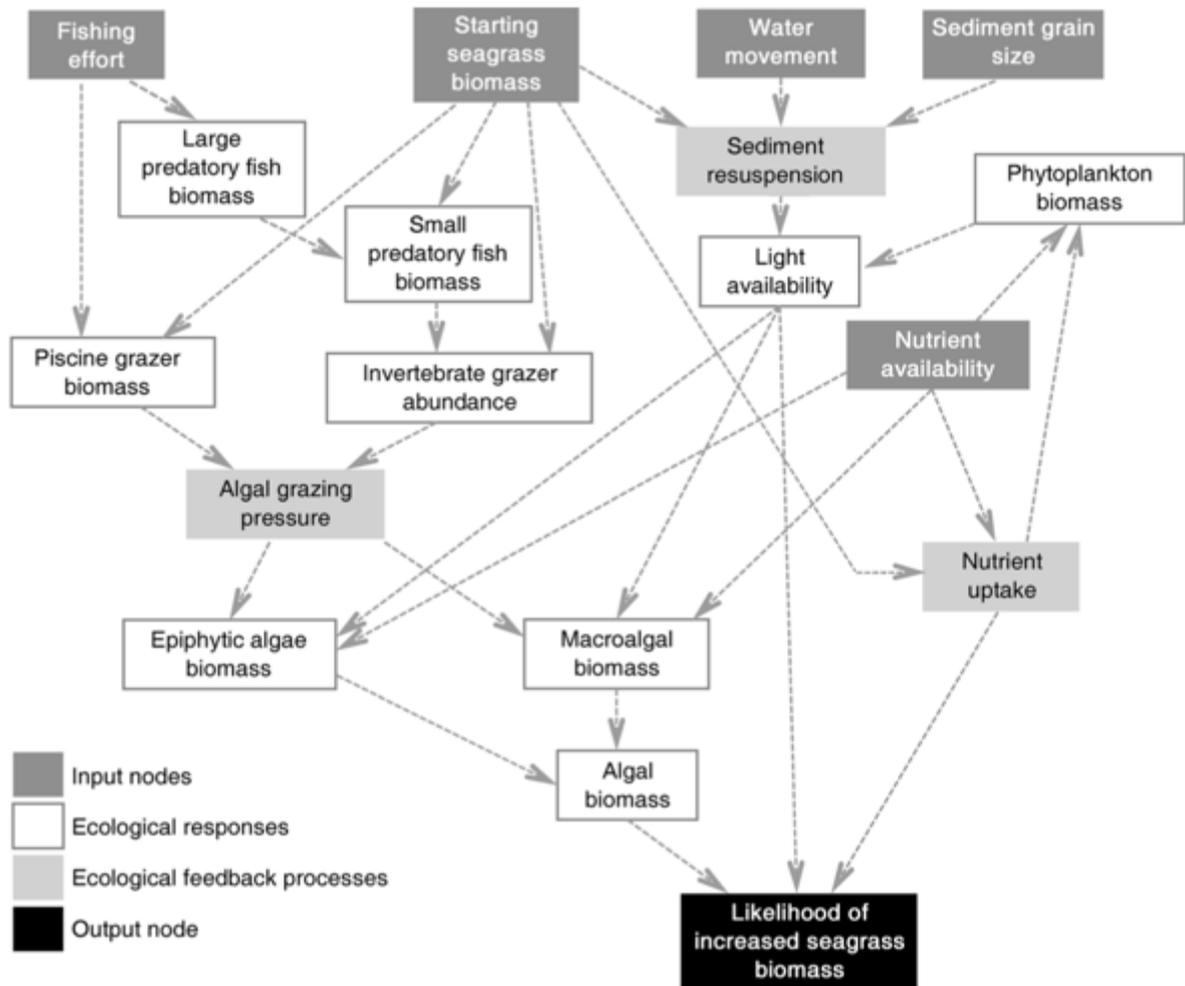
Figure 30 Bayesian Network Conceptual Framework for *Zostera* seagrass resilience in Moreton Bay (Maxwell et al 2015).

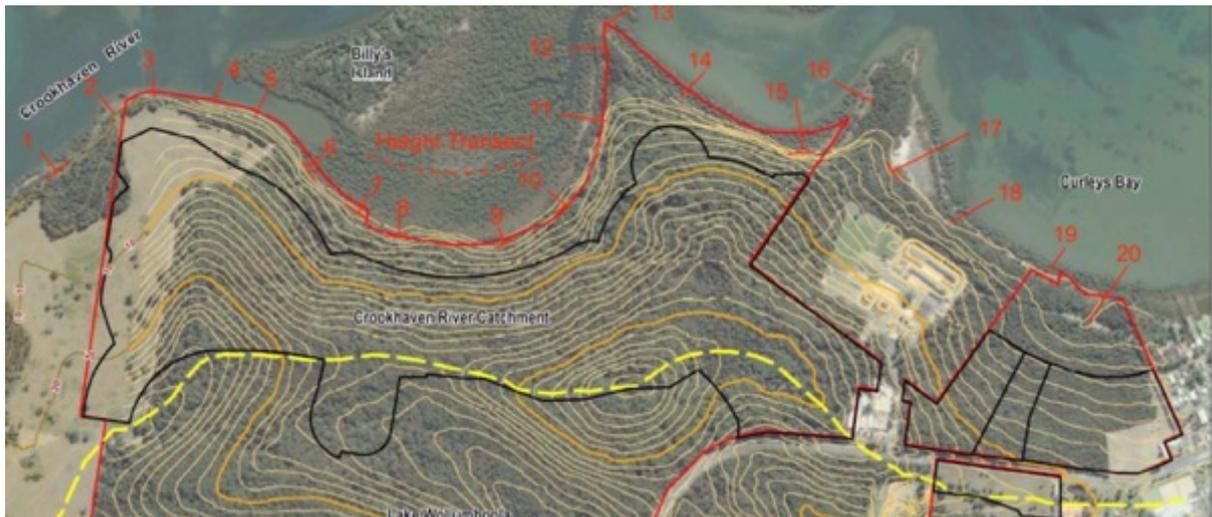
Figure 1 Proposed locations of 20 shore normal transects to ascertain site runoff characteristics and terrestrial to estuarine ecotones.

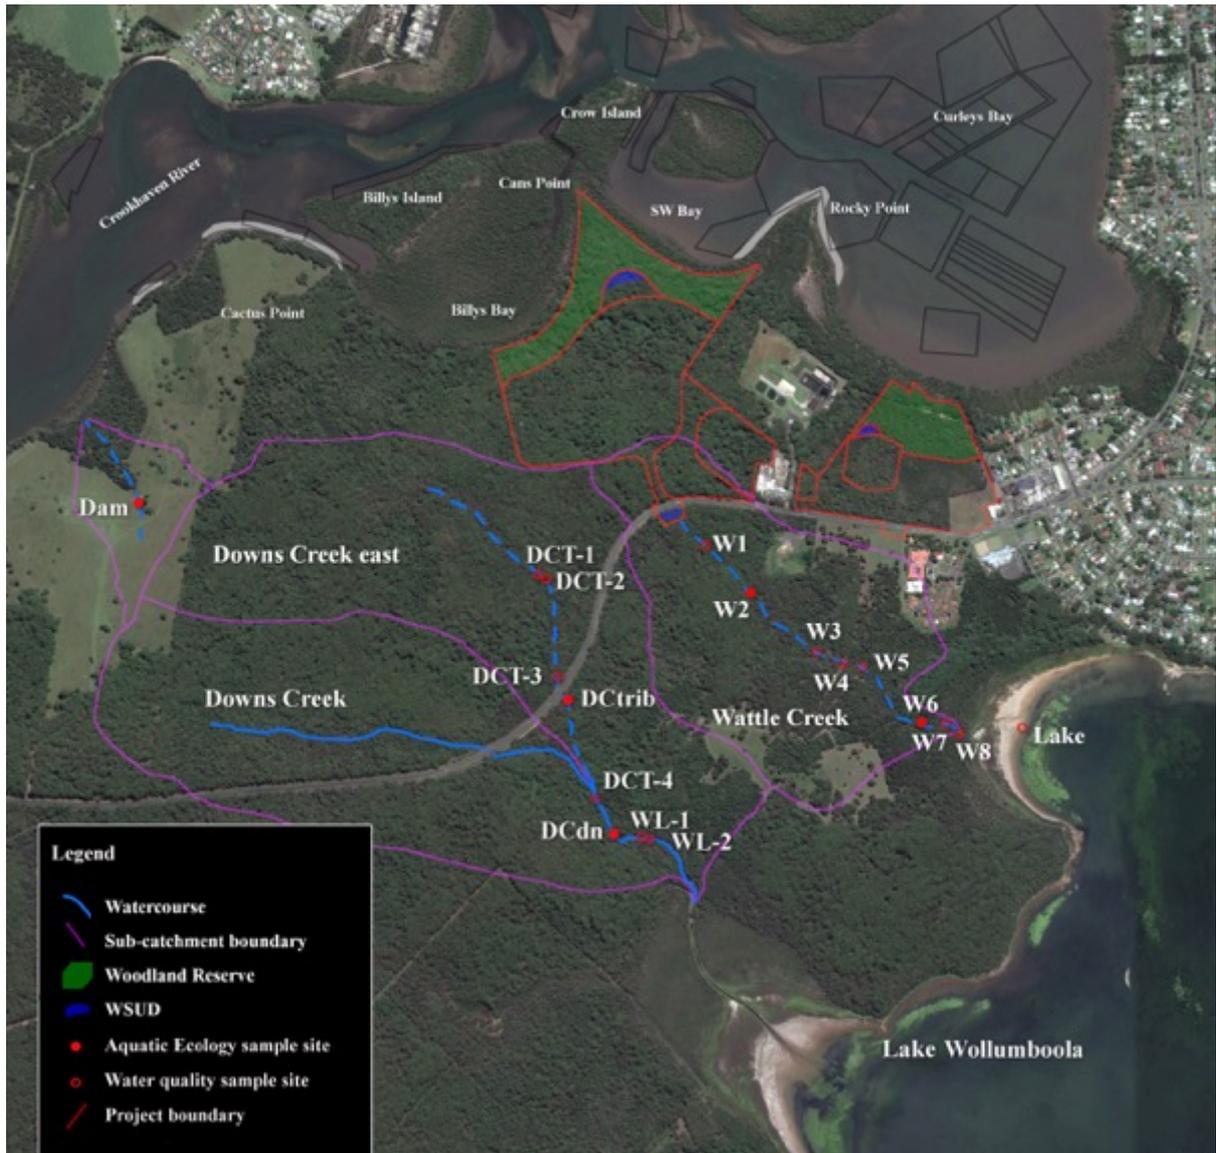
Figure 1: Freshwater habitat assessment sites bounding West Culburra development proposal showing drainage lines in blue (note that dash lines represent unnamed and ephemeral drainages).

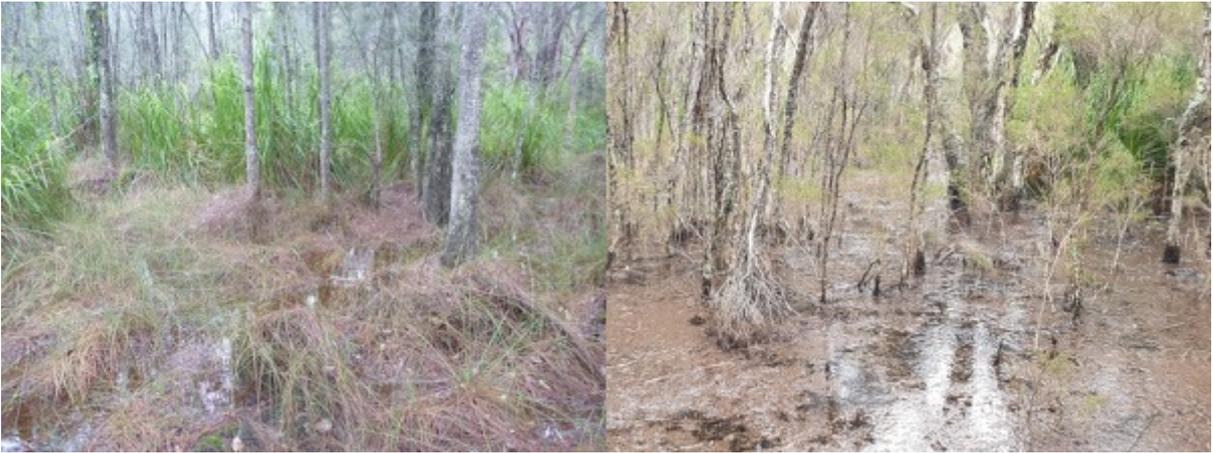
Figure 3: Downstream locations in Wattle Creek showing Casuarina dominated swamp forest (left) and paperbark swamp forest (right) that was inundated at the time of inspection.

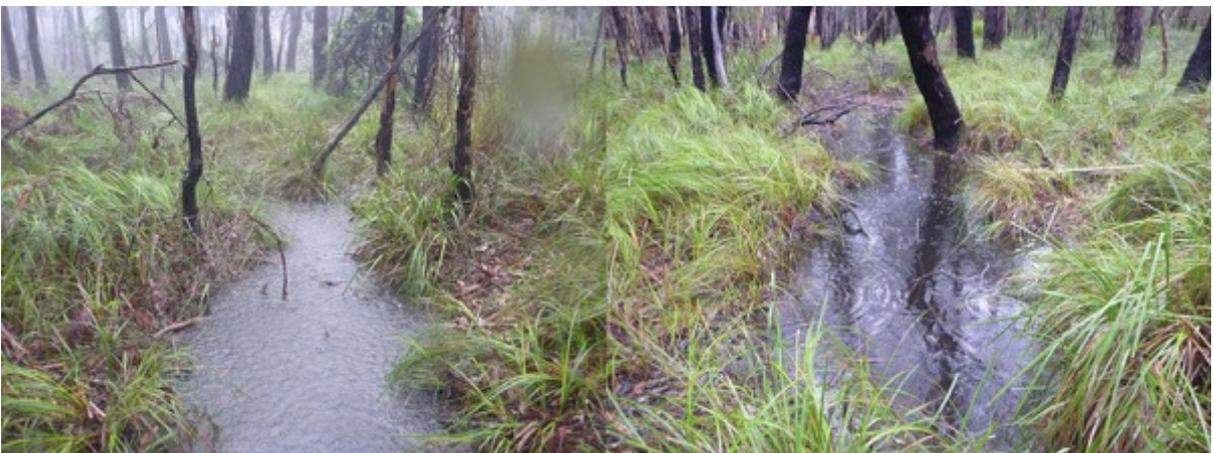
Figure 4: Looking upstream at site W1 (left) and W2 (right), two temporary pools that were filled during the wet conditions. Maximum pool depth (at saturation) reached 0.4m and maximum length was 11m.

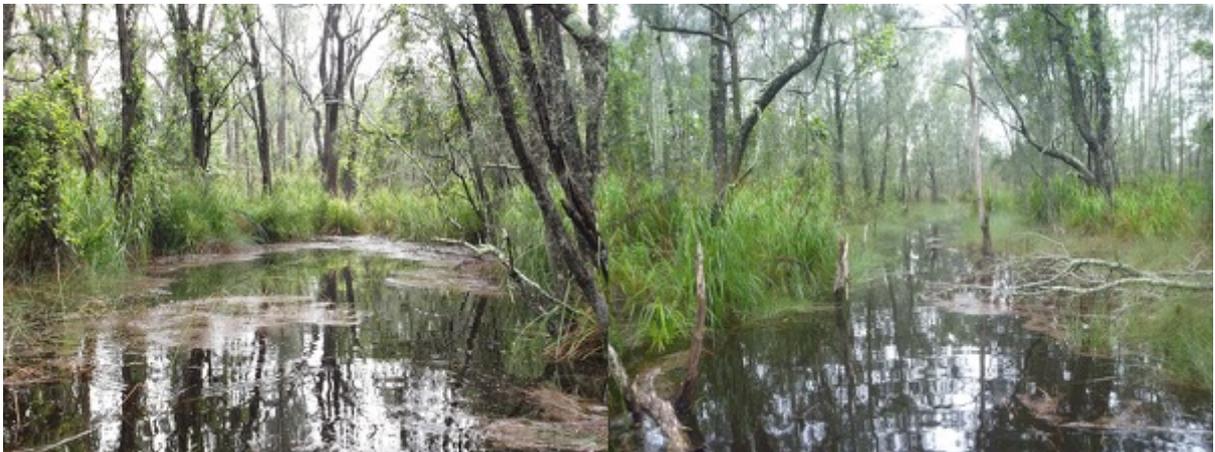
Figure 5: Looking downstream in W6 incised channel area with larger pool (left) and meandering narrower channel (right).

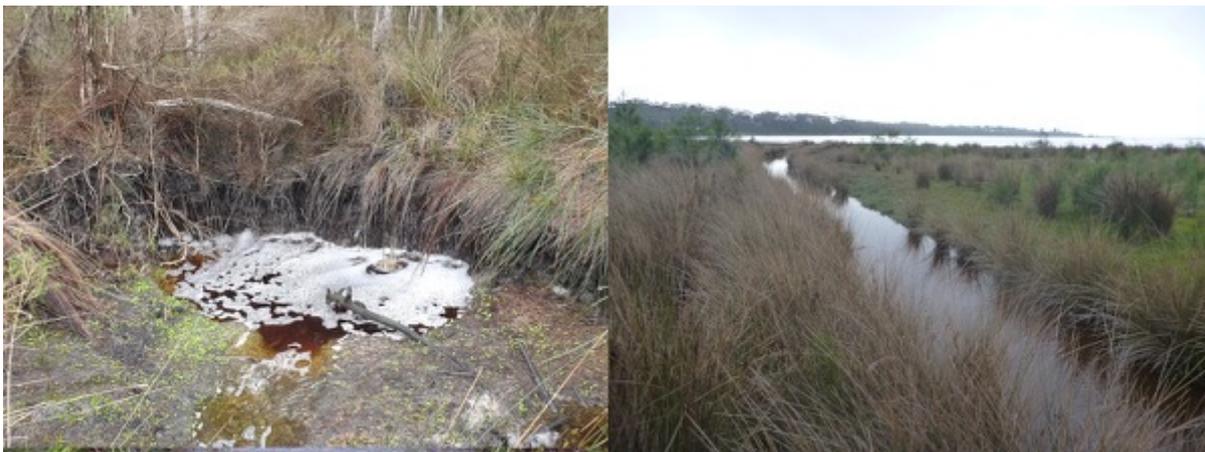
Figure 6: Wattle Creek downstream overflow point into upper Wollumboola Lake inlet channel (left) and looking downstream through fringing saltmarsh habitats bordering the inlet channel (right).

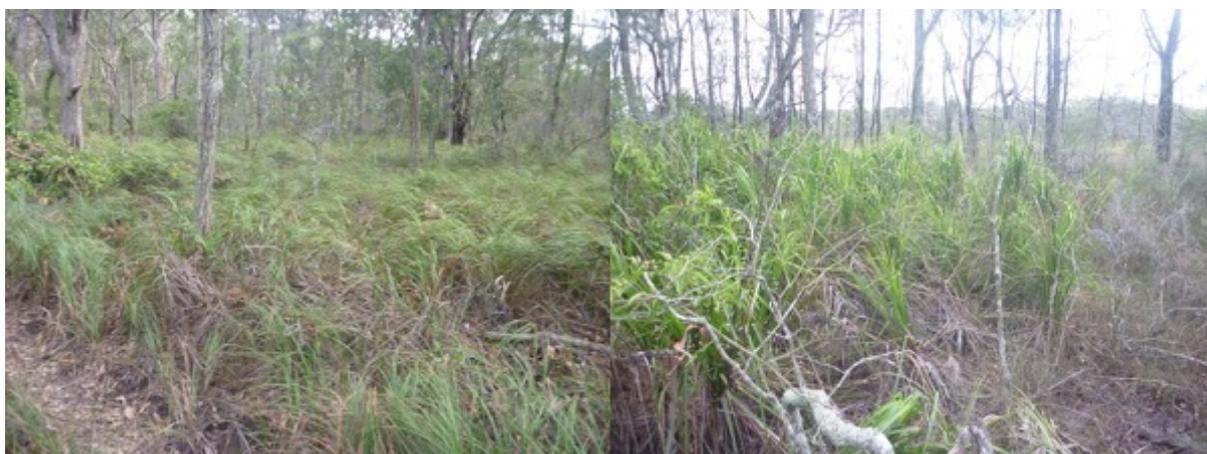
Figure 11: Broad occupation of saw-sedge on riparian slopes upslope from Billys Bay foreshore (left) which were moist but supported no surface water during the wet weather survey in February 2020. Isolated stands of tall saw-sedge (left) which are common in the study area, mostly around the lower riparian zone (behind saltmarsh). There were only small amounts of shallow surface water during the February 2020 field inspection (see **Figure 12** below).

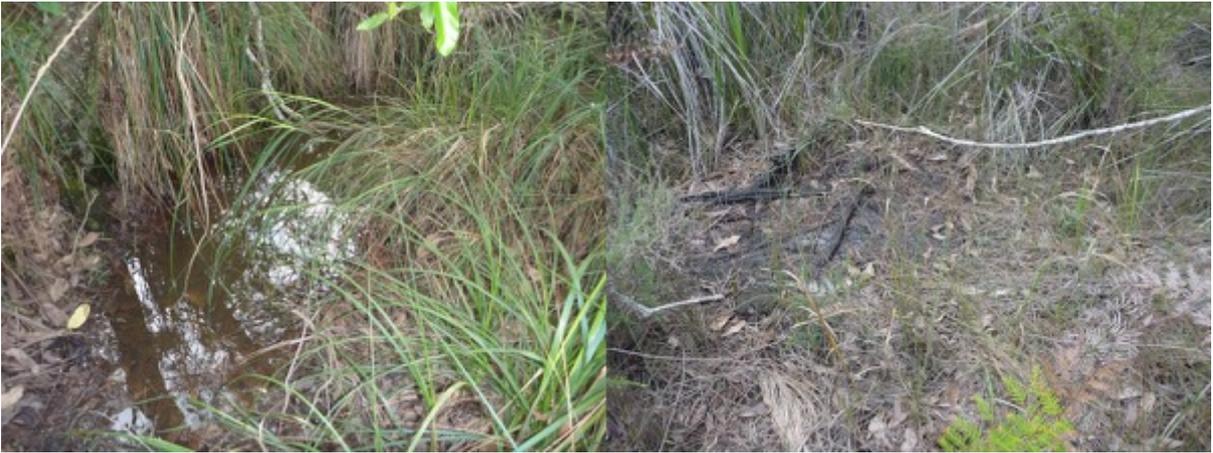
Figure 12: Riparian zone incised channel filled with water during the February 2020 survey (left) and shallow surface water puddle adjacent to tall saw-sedges (right). Low points throughout the saltmarsh habitats also contained very shallow pooled water in February 2020. In Billys Bay there were seepages discharging to the estuary from the interface between saltmarsh and mangrove zones, in the form of consistently occurring minor trickles, and this phenomenon was also observed throughout much of the steep eroded face of the riparian ‘berm’ along the Cactus Point foreshore (**Figure 13**).

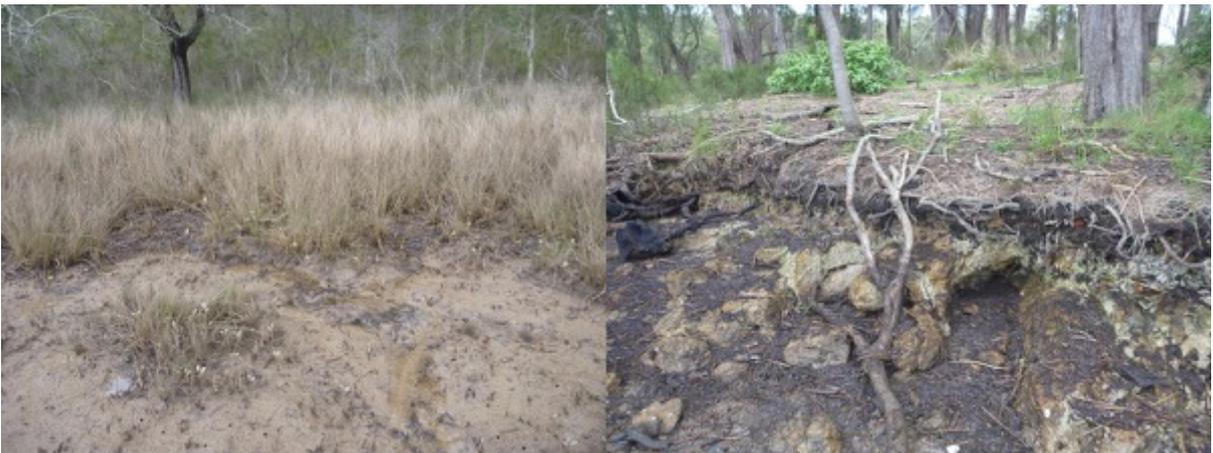
Figure 13: Seepage discharge from the saltmarsh zone into the estuary in Billy Bay foreshore (left) and from the riparian edge bank face along Cactus Point (right). These observations provide indications of how rainfall infiltration discharge to the estuarine waters.

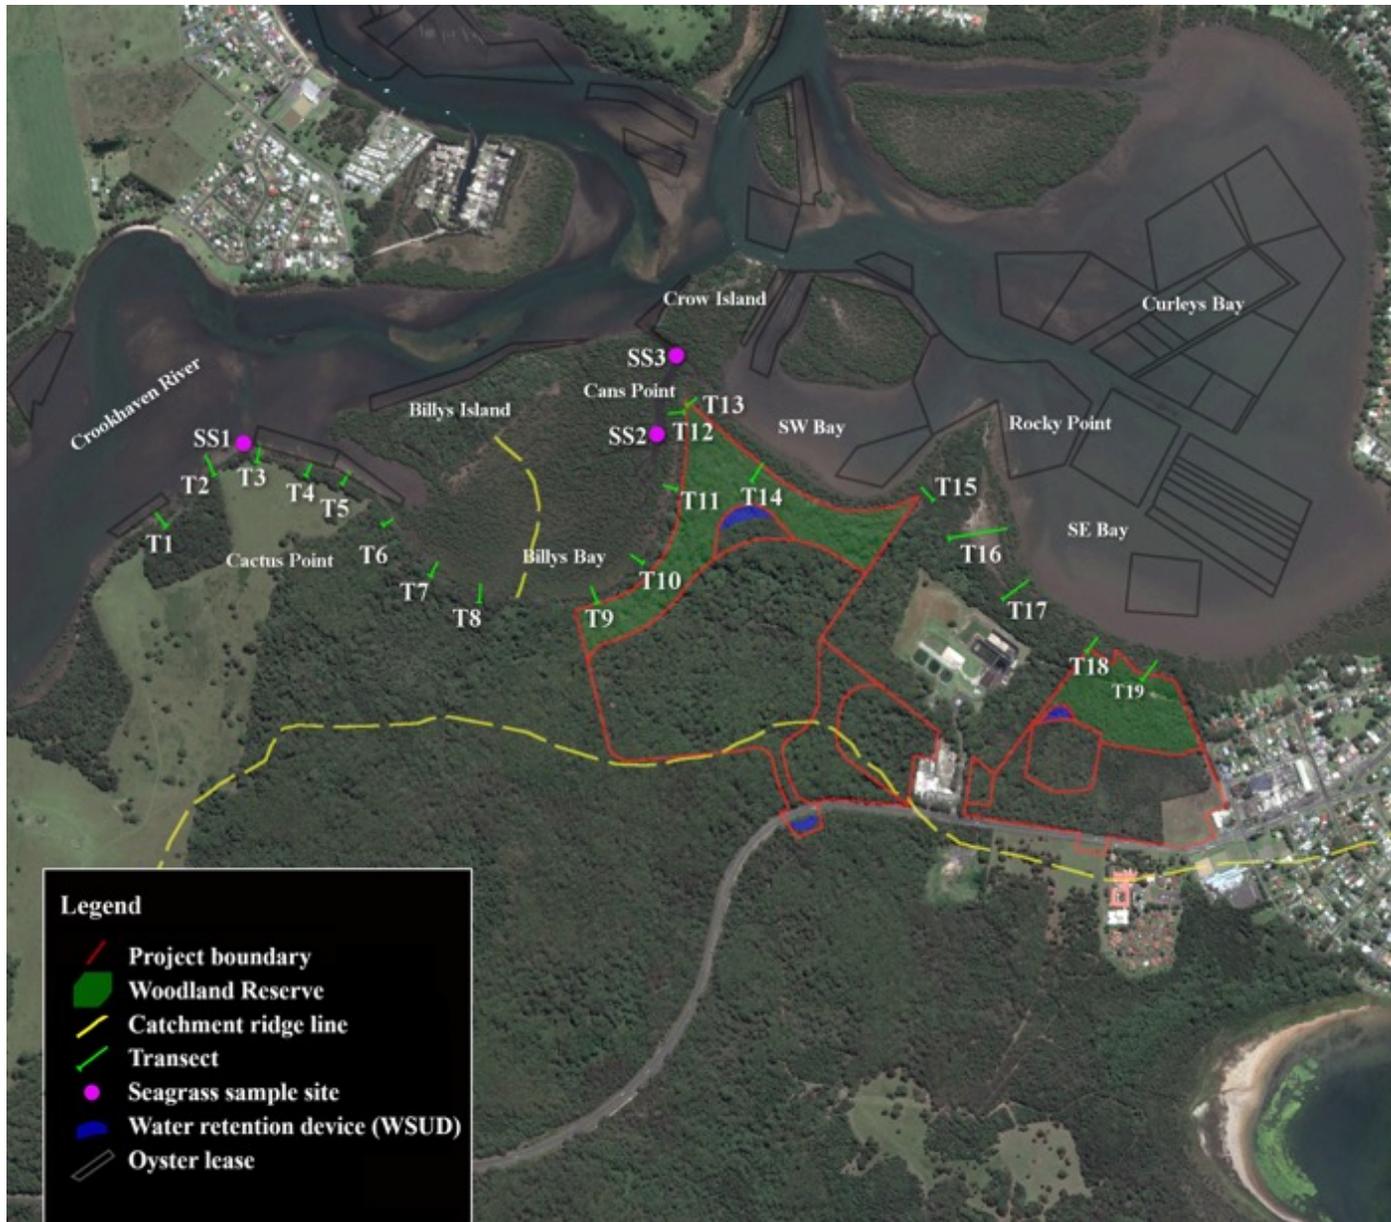
Figure 2: Estuarine aquatic ecology habitat assessment sites bounding the revised Concept Plan. Note the delineation of mangrove drainage areas inshore in Billys Bay (dashed white line).

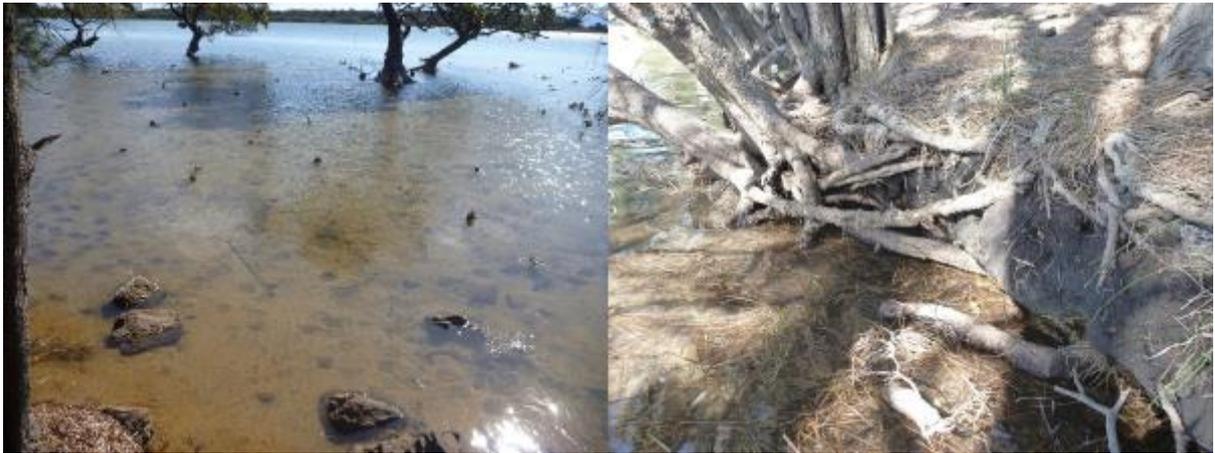
Figure 3: Cactus Point shoreline showing intertidal zone, with very sparse grey mangrove occupation (left) and example of undercut banks forming a distinct, stepped edge (right). This area is heavily grazed (note the cattle hoofprints in the sediments on the left photo).

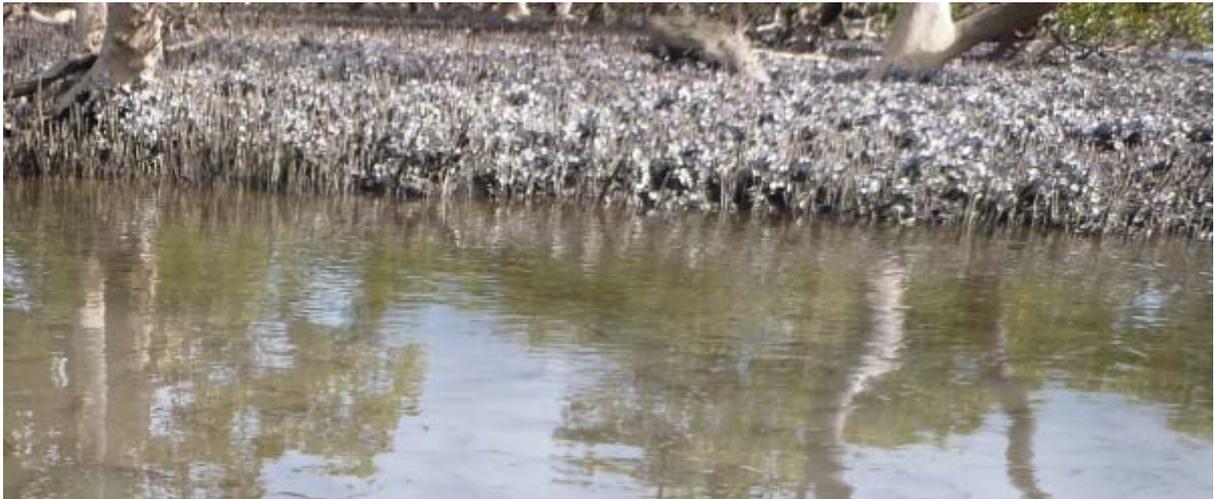
Figure 6: Oyster growth on mangrove pneumatophores along the northern edge of Billys Bay eastern channel.

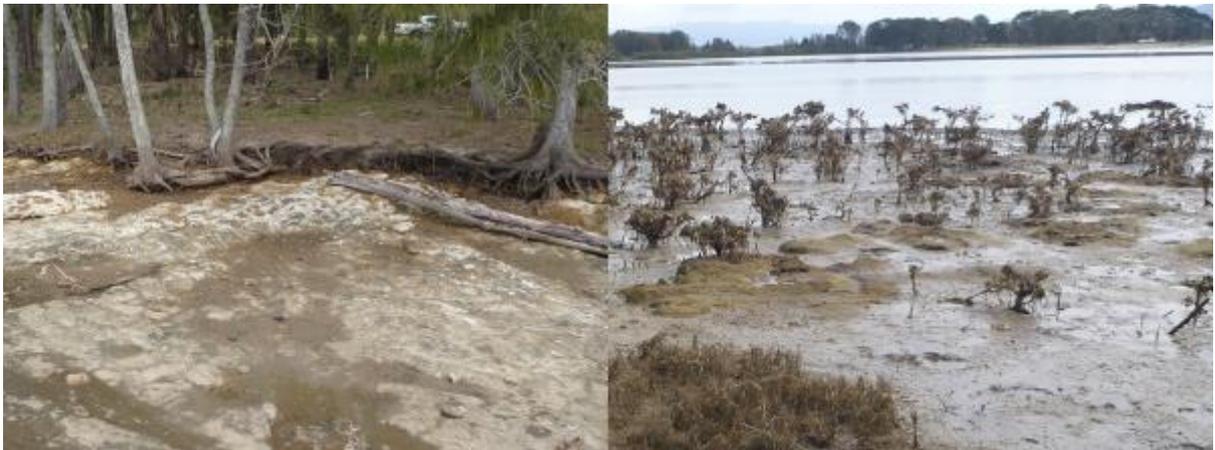
Figure 7: Exposed bedrock platforms along Cactus Point shoreline fronting the Crookhaven River. Rocky substrates meeting undercut riparian banks stabilised by Casuarinas at Transect 5 (left) and bedrock outcrops among shallow sediment intertidal mangrove habitats in Transect 2 (right).

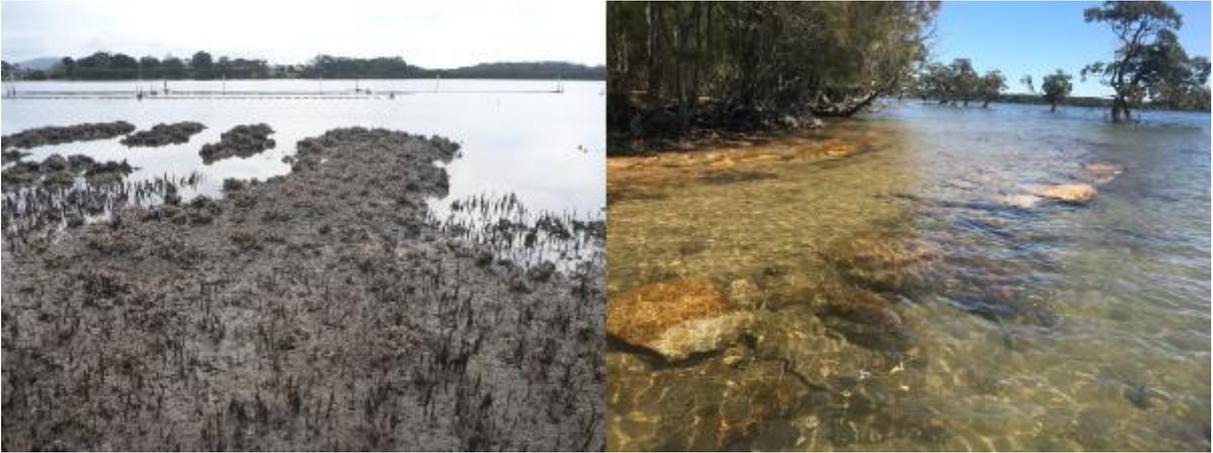
Figure 8: Oyster catching rock deposits along the Crookhaven River fronting Cactus Point at Transect 3 (left) and shoreline boulder rock deposit submerged by high tide (right). This latter example of rocky habitats supported very little encrusting fauna or flora.

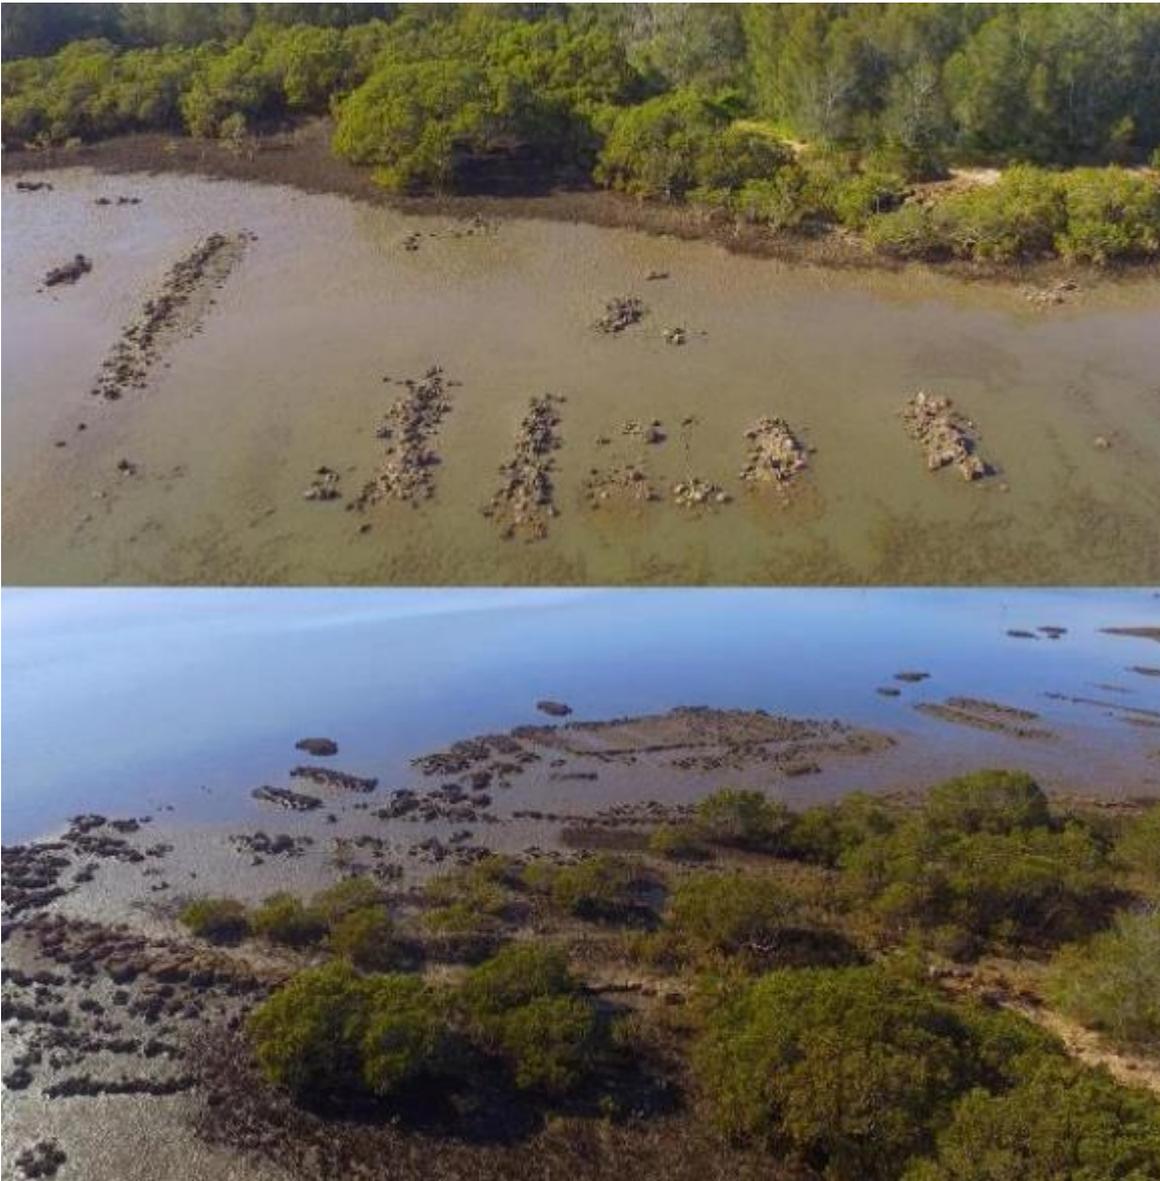
Figure 9: Intertidal rock and shell bed habitats around Rocky Point. This section of shoreline included deposited boulders still used for catching oysters (top and bottom) and natural bedrock outcrops (bottom) with areas of shell beds (not shown).

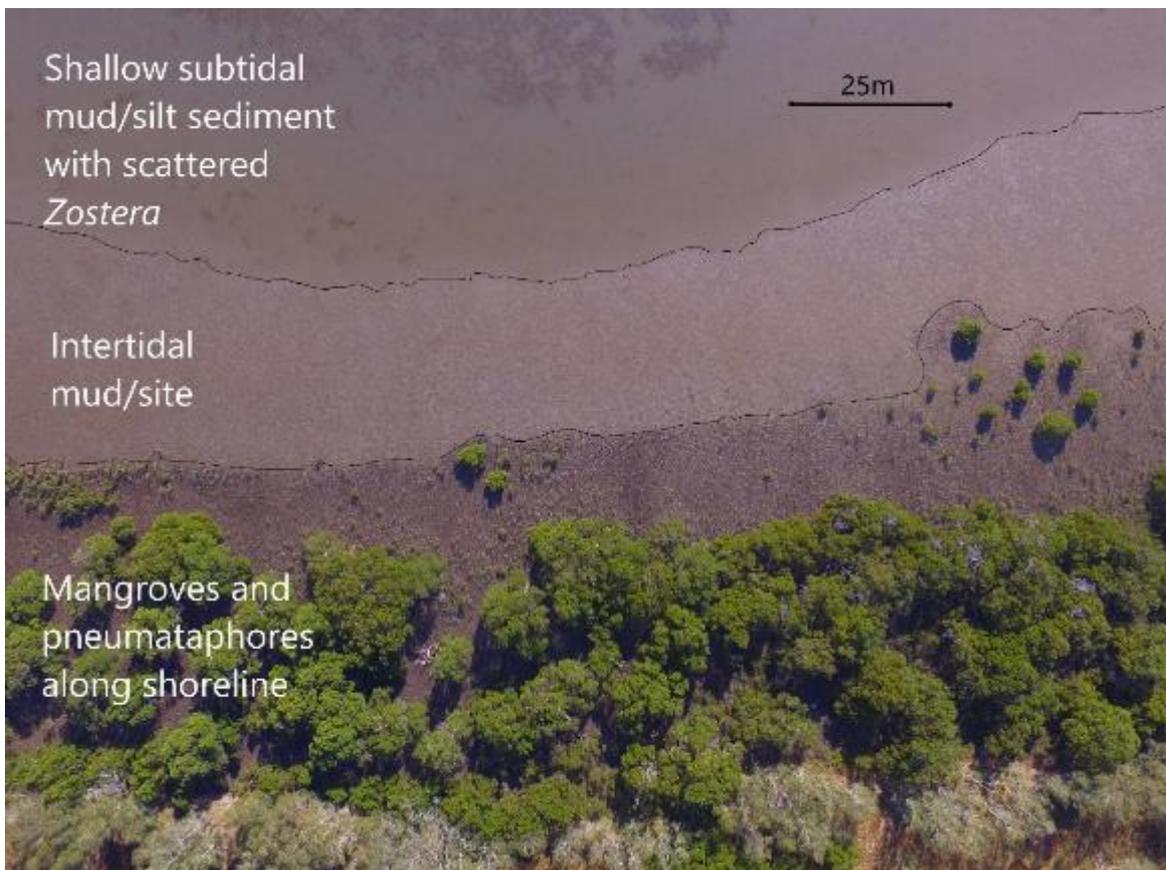
Plate 20: Drone shot of a section of SW bay. Typical intertidal zonation of Culburra West shoreline (5/9/20 low tide).

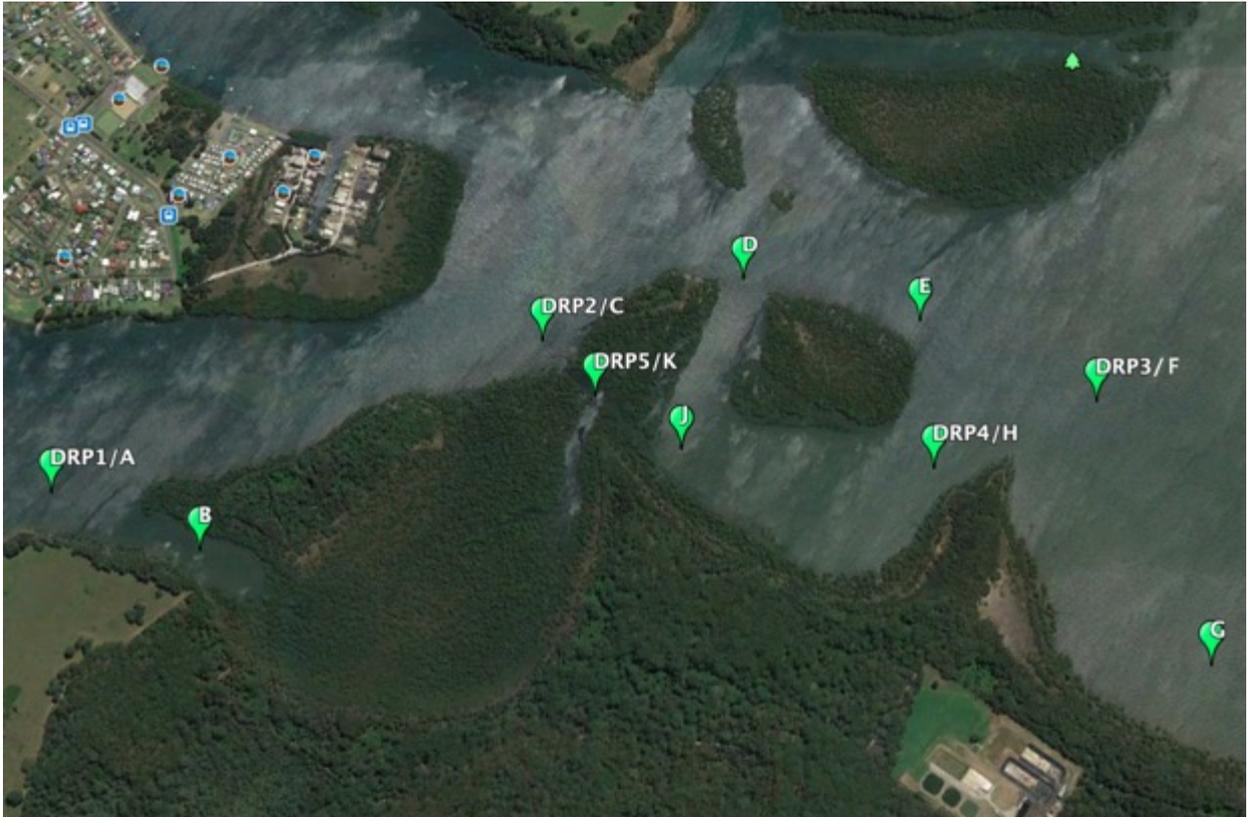
Figure 1 Location of 10 water quality monitoring sites in the Crookhaven River and Curleys Bay
