REVISED WEST CULBURRA BEACH CONCEPT PLAN

AQUATIC ECOLOGY ASSESSMENT REPORT

**Marine Pollution Research Pty Ltd
November 2020**

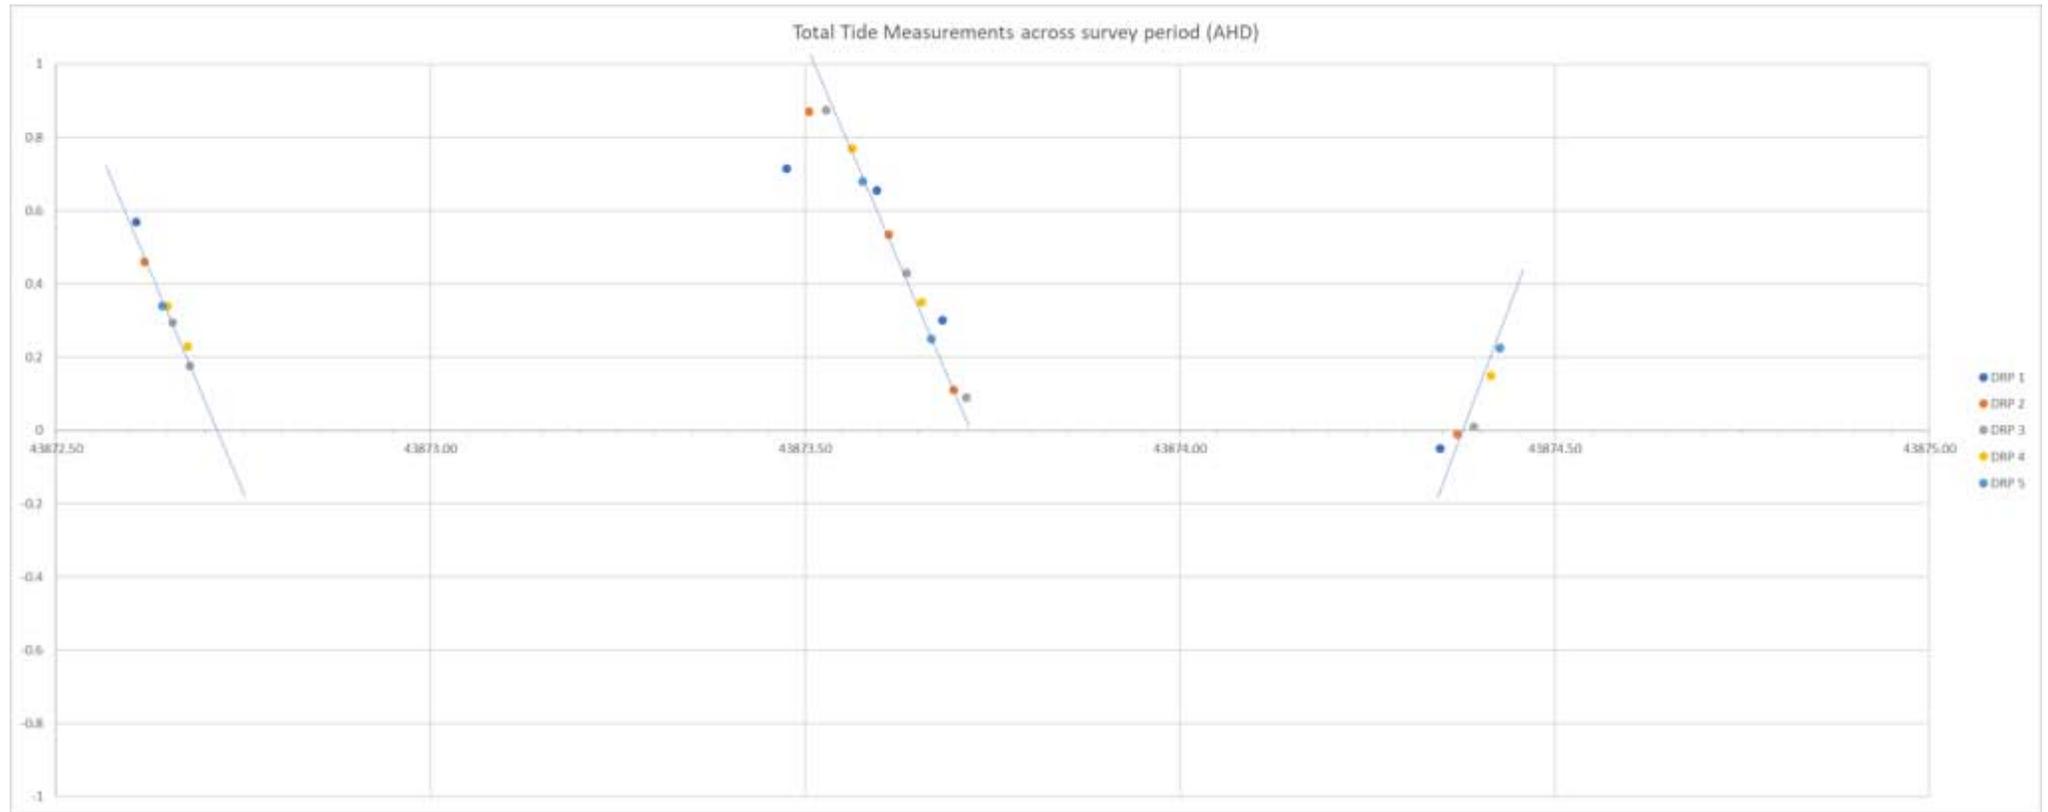
Figure A-1 Tide Data for the Five Tide gauge Sites 11 Feb (day 43852) to 13 Feb (day 43854)

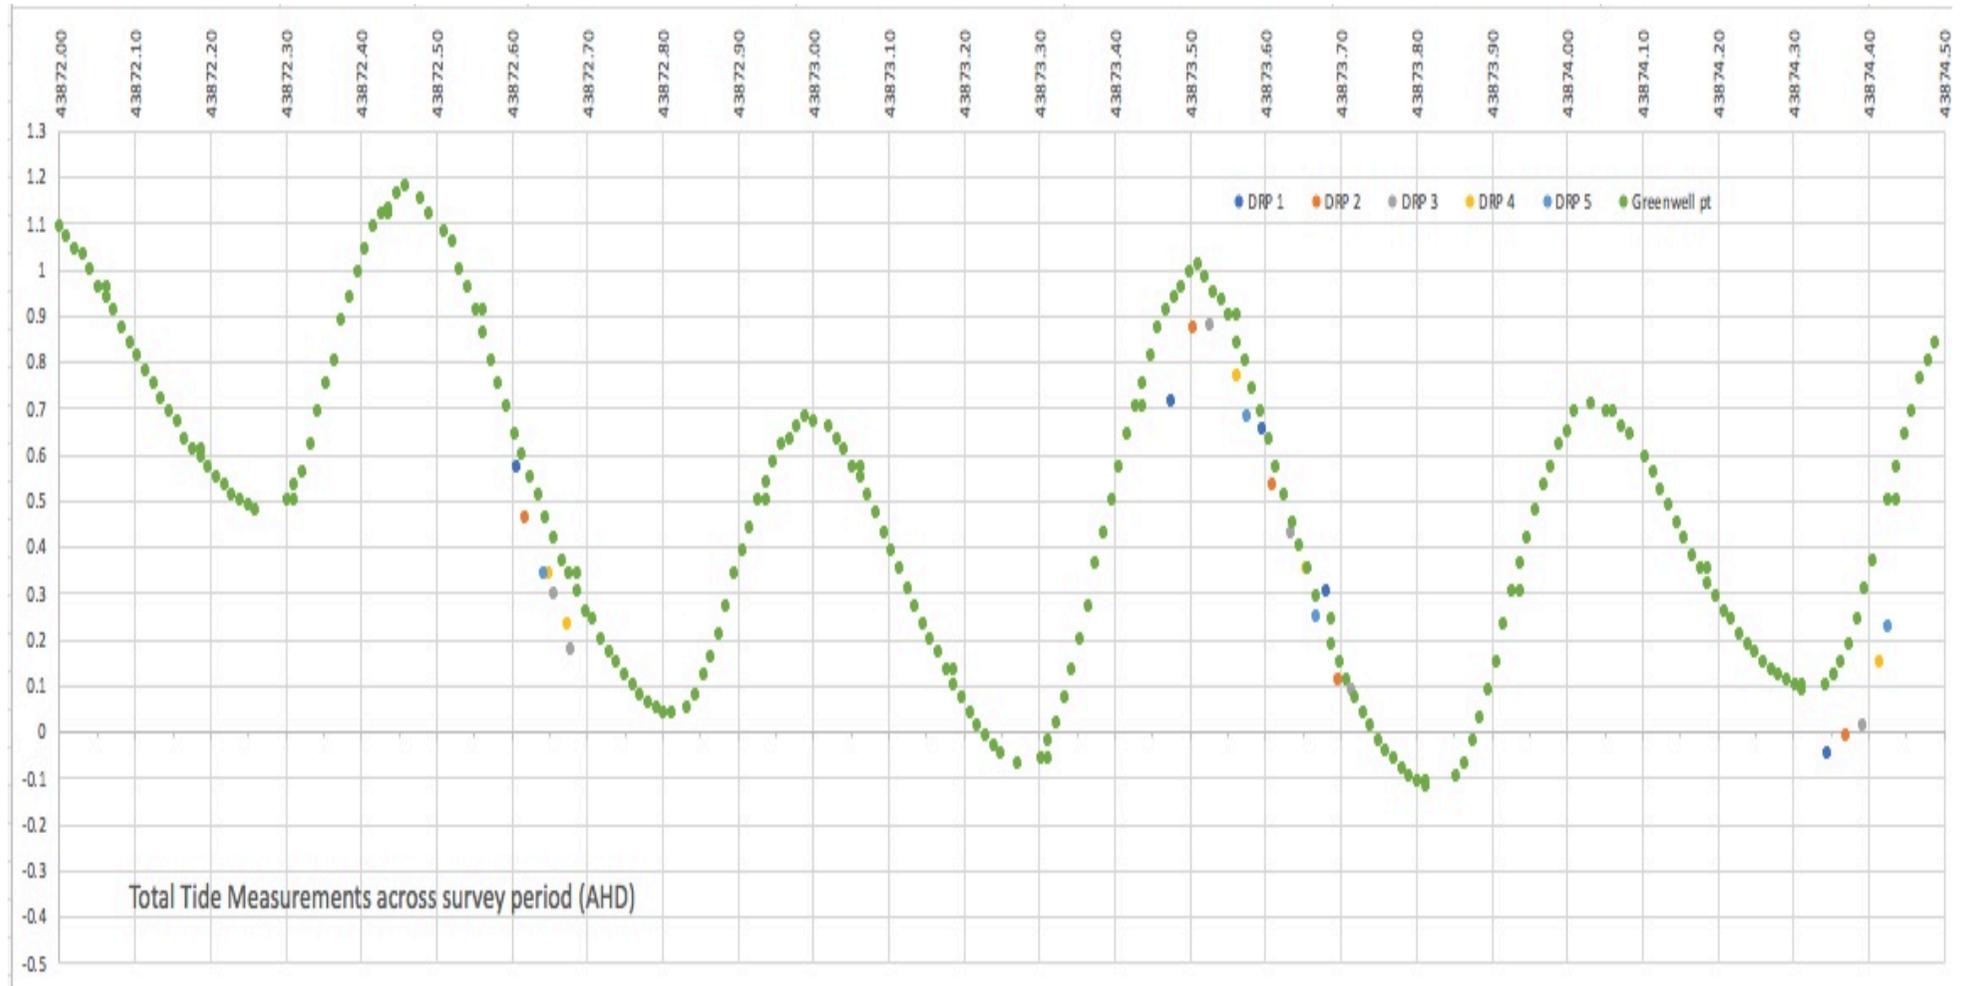
Figure A-2 Tide Data for the Five Tide Gauge Sites 11 Feb (day 43852) to 13 Feb (day 43854) superimposed over Greenwell Point Tide Gauge data

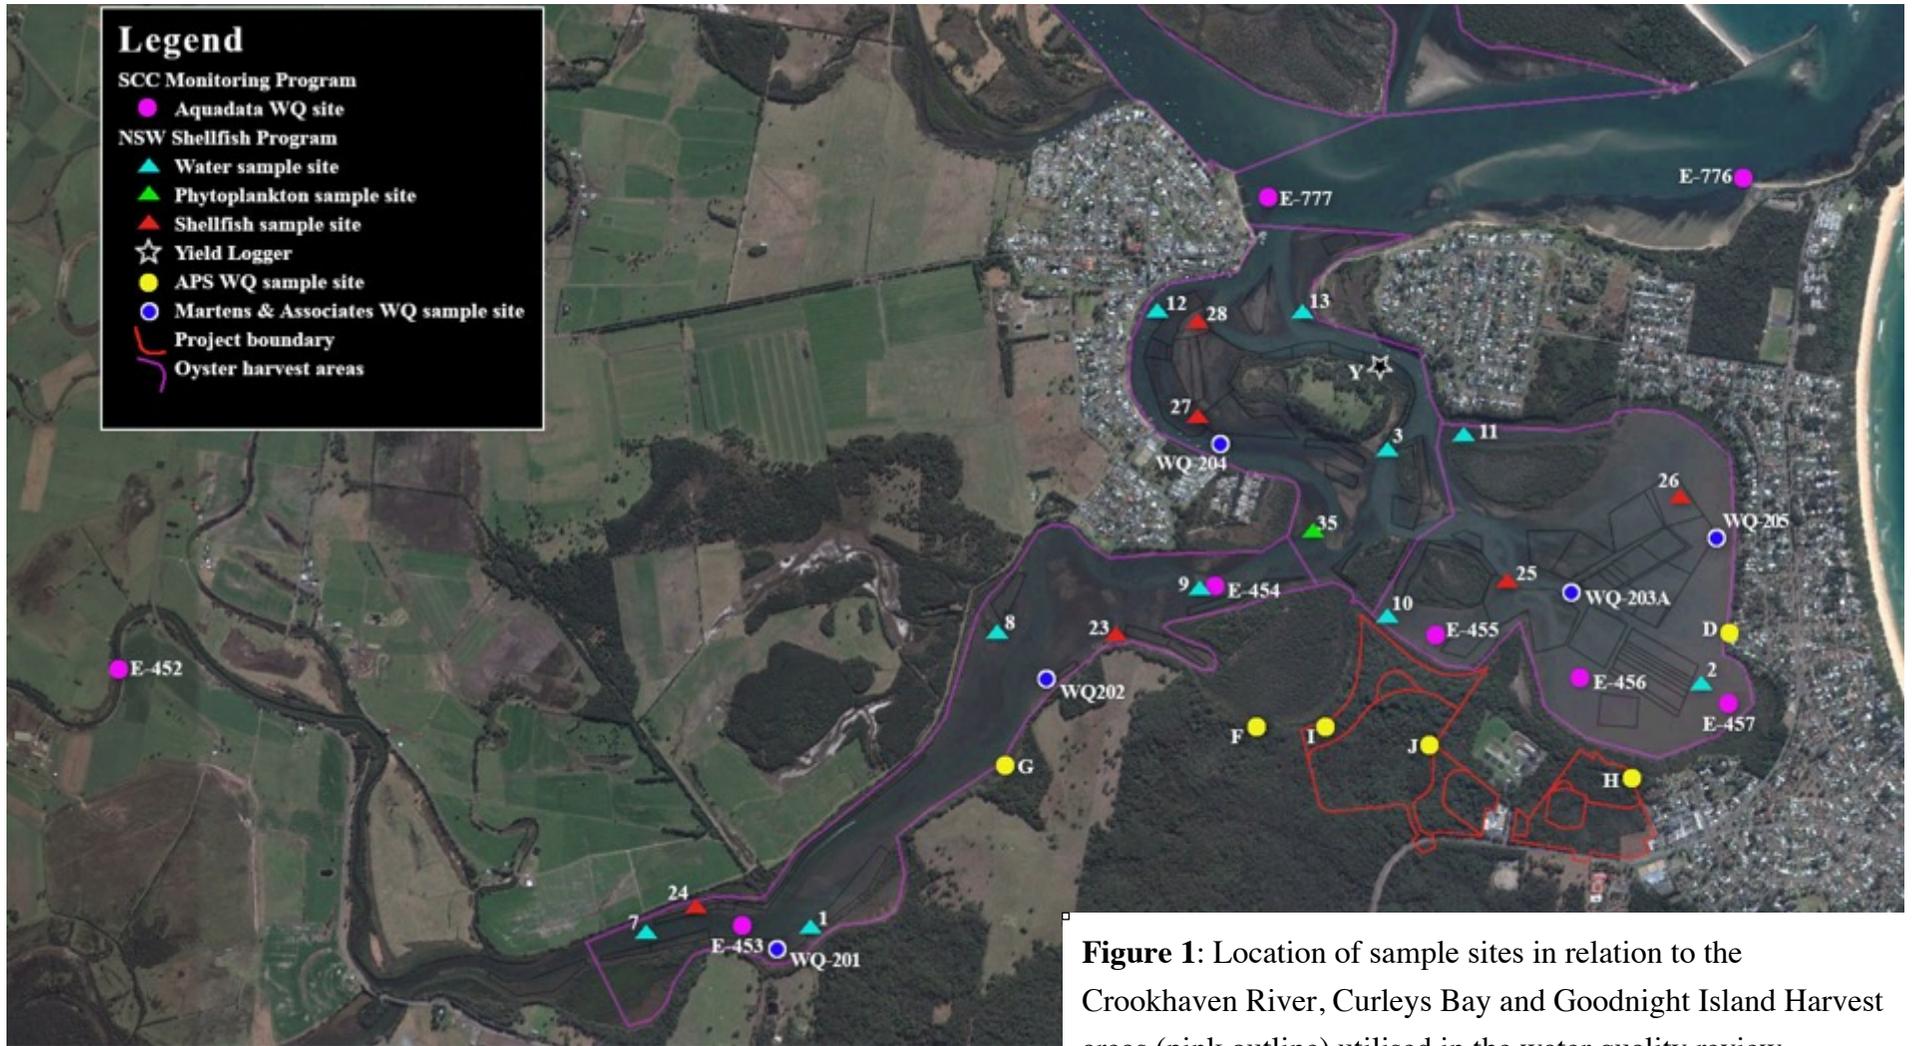
Figure 1: Location of sample sites in relation to the Crookhaven River, Curleys Bay and Goodnight Island Harvest areas (pink outline) utilised in the water quality review.

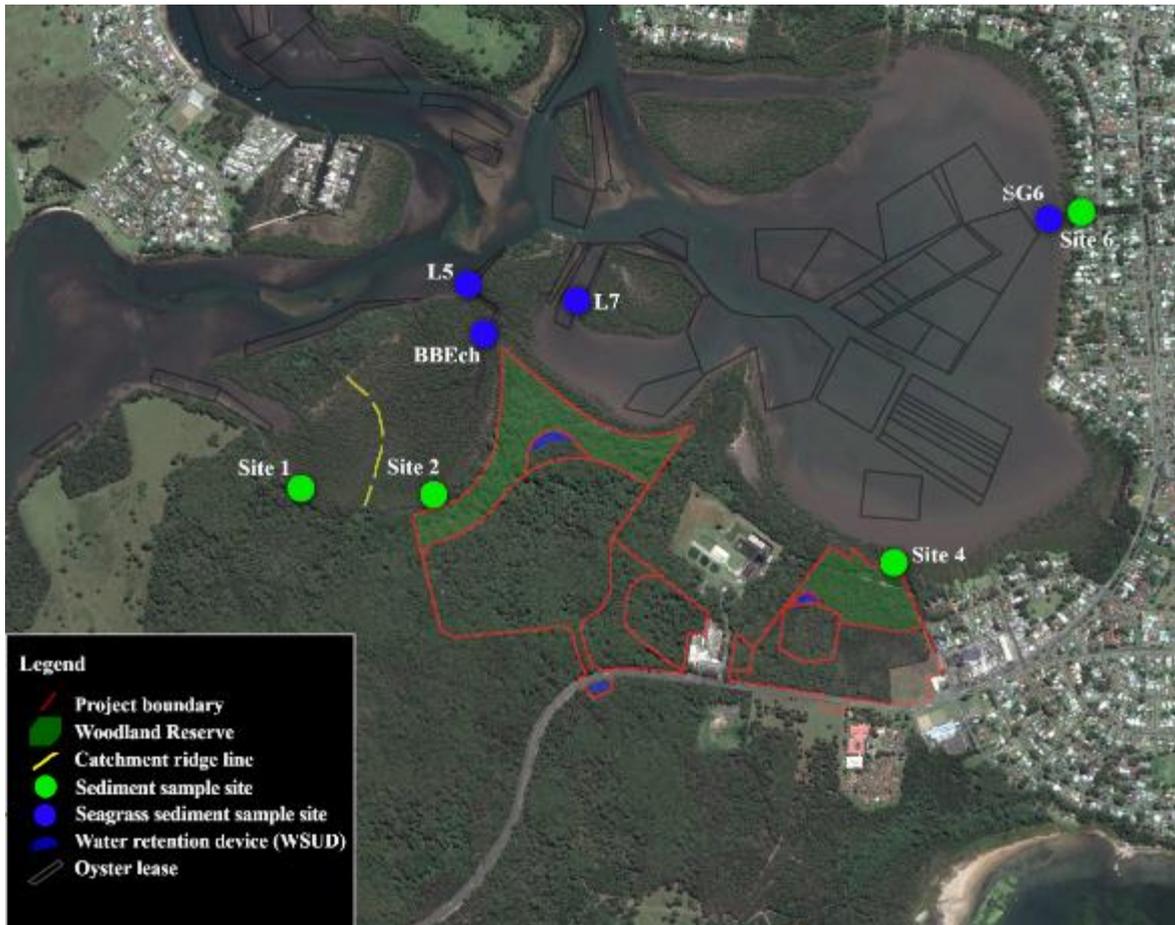
Figure 1: Curleys Bay Sediment Study sample site locations

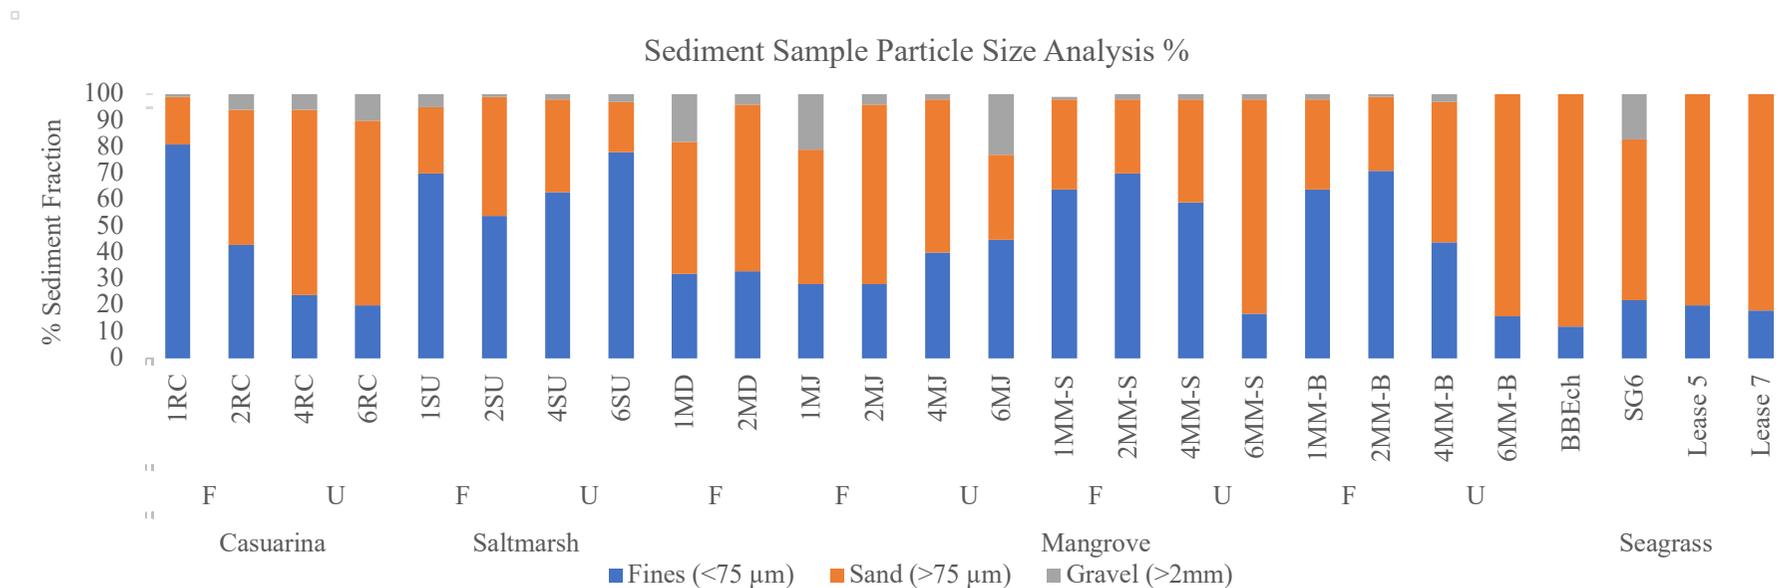
Figure 2: Sediment sample particle size distribution (% total).

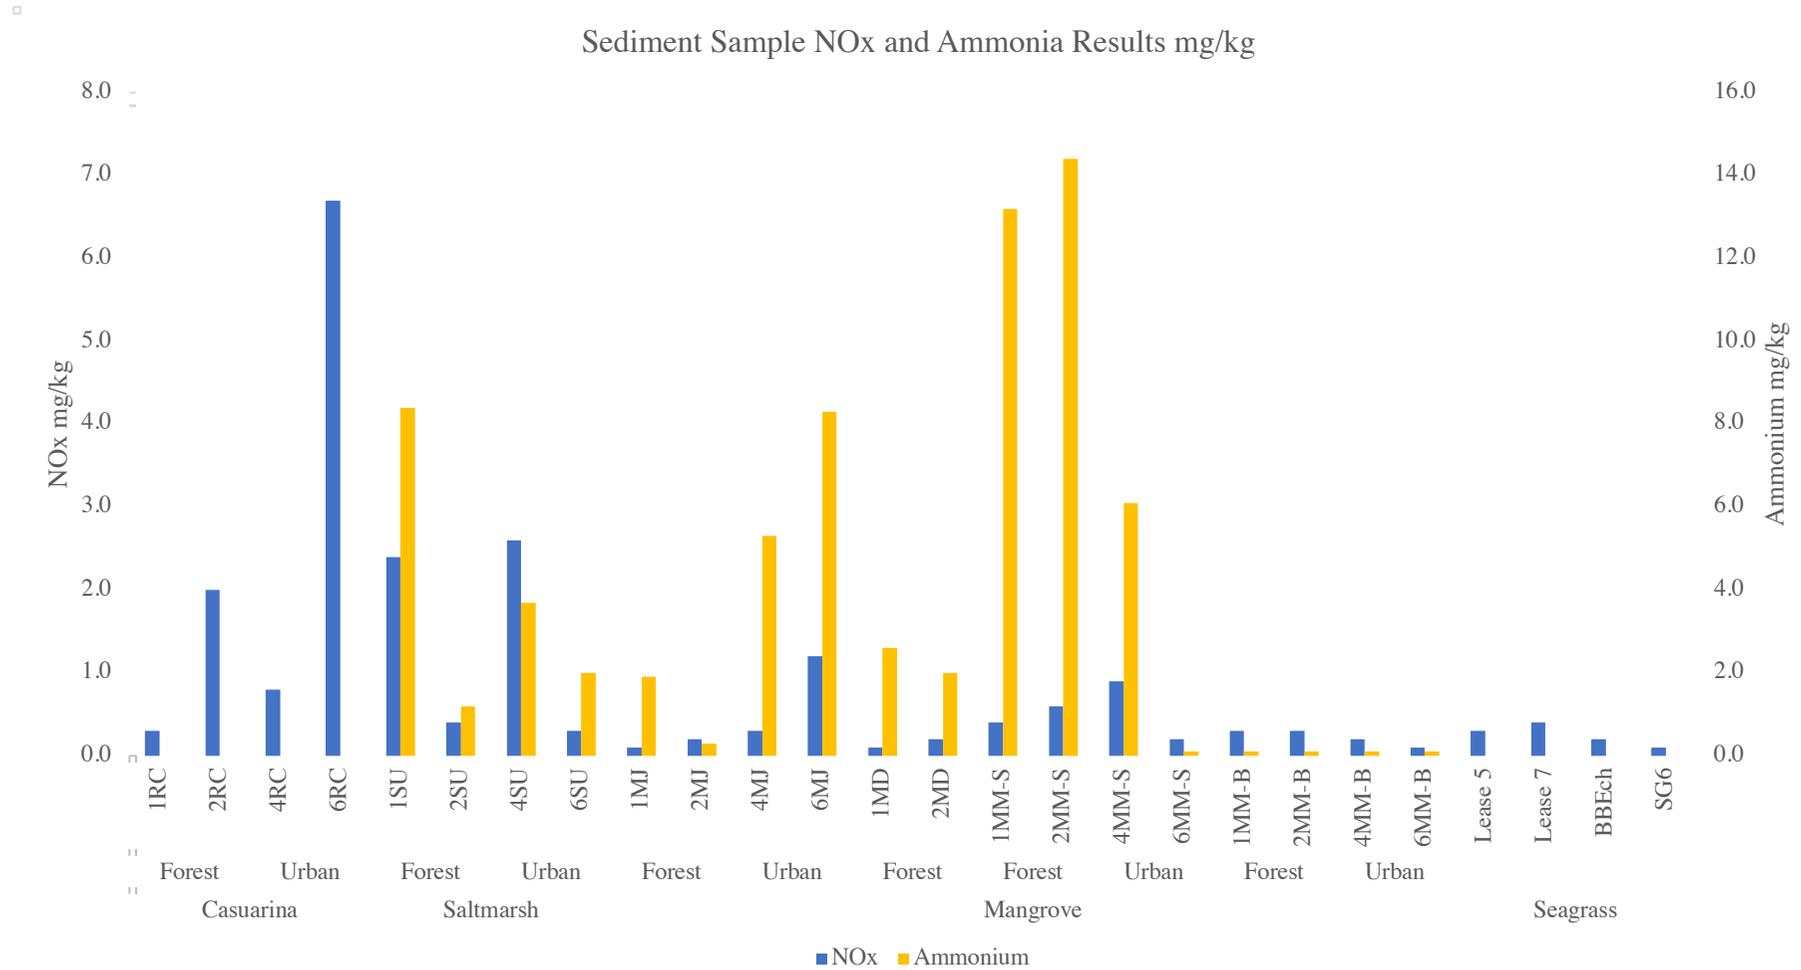
Figure 4: Sediment sample Nitrous Oxides (NOx) and Ammonium concentrations across site groupings.

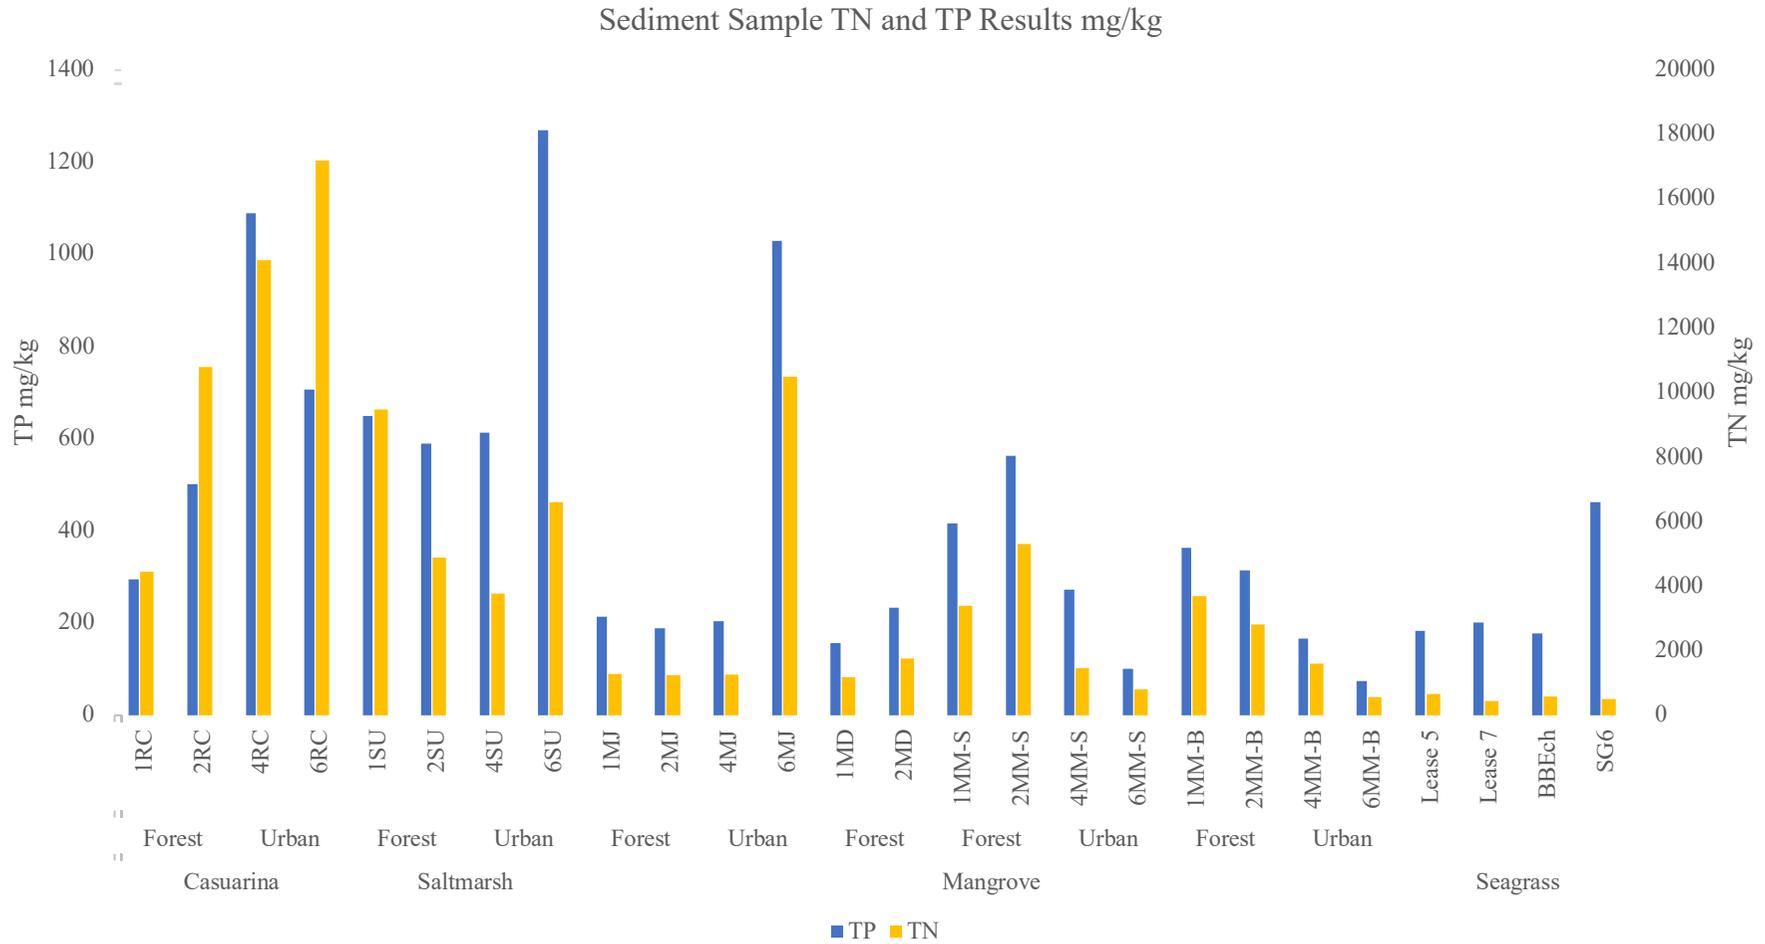
Figure 5: Sediment sample Total Nitrogen (TN) and Total Phosphorous (TP) concentrations across site groupings.
